Lockup Stage Inspection

Inspection Date: 6 Jun 2025

Company Name: The Building Inspection Doctor

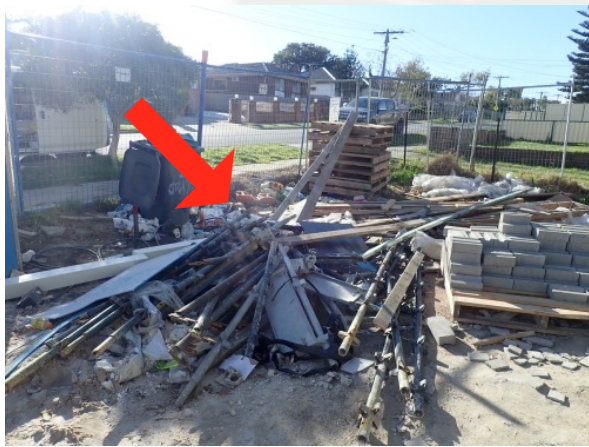
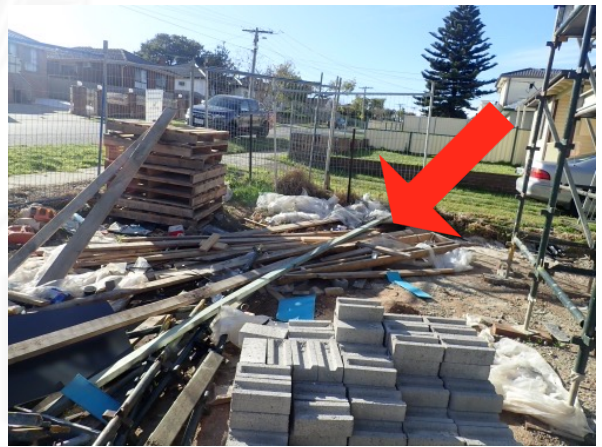
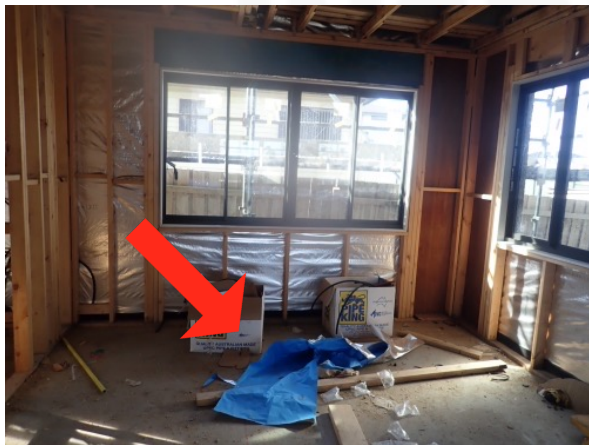
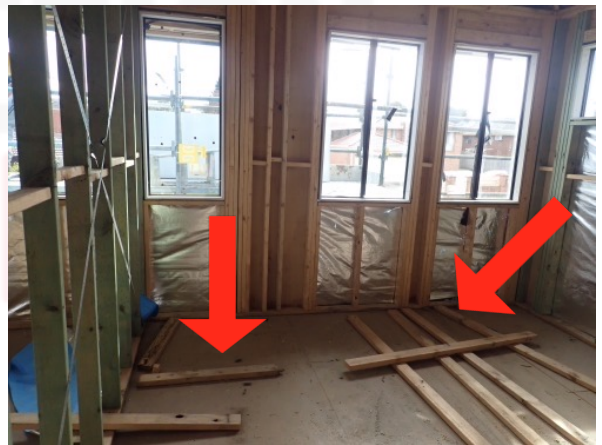
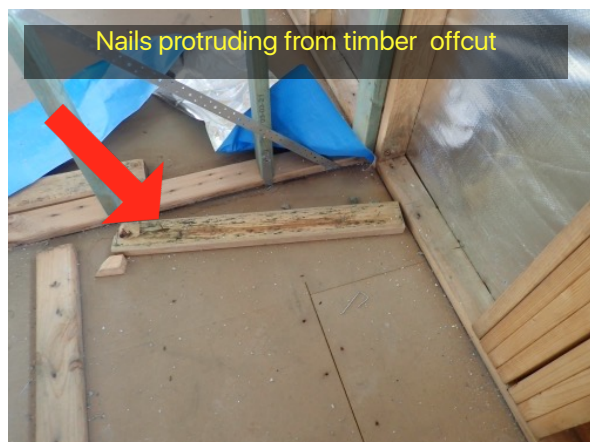
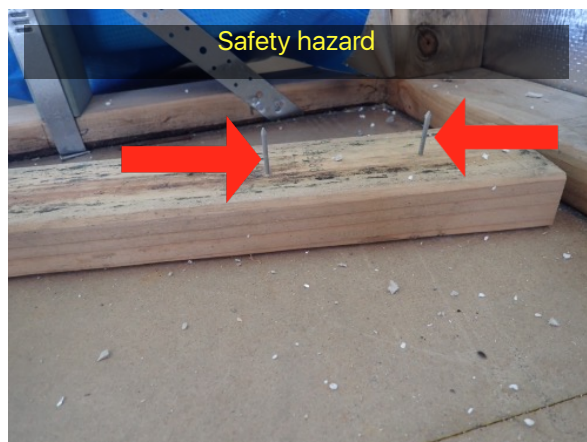
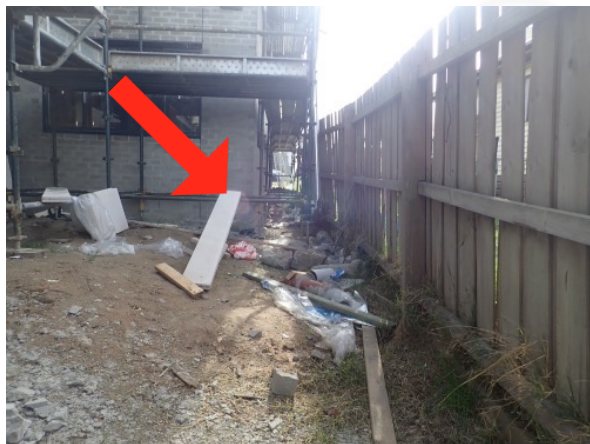
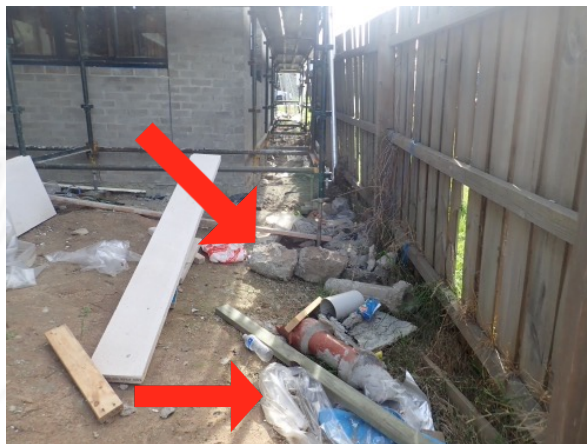
Safety Hazard 1.01

Finding: Builders Debris - Requires Cleaning

The garbage and builders debris that has built up around the site is a safety hazard and requires removal.

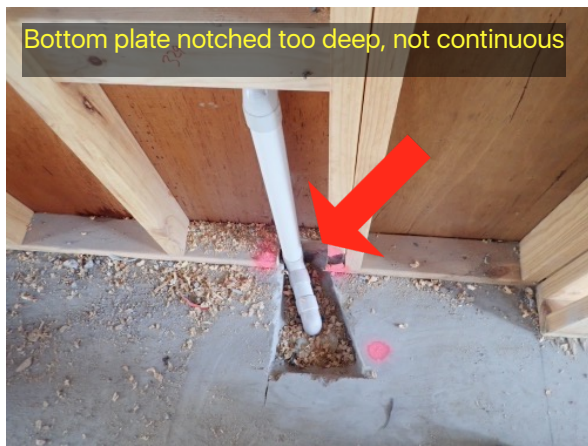
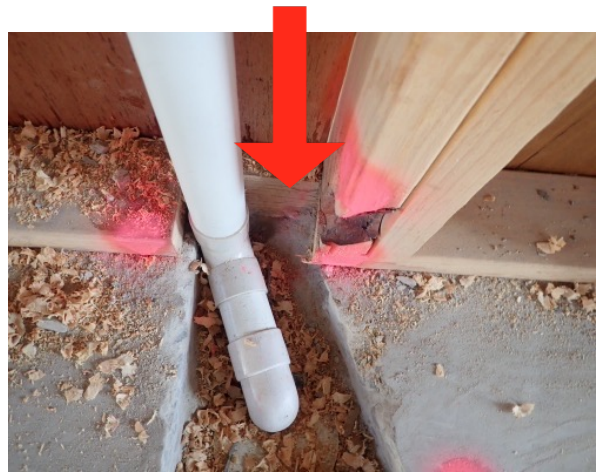
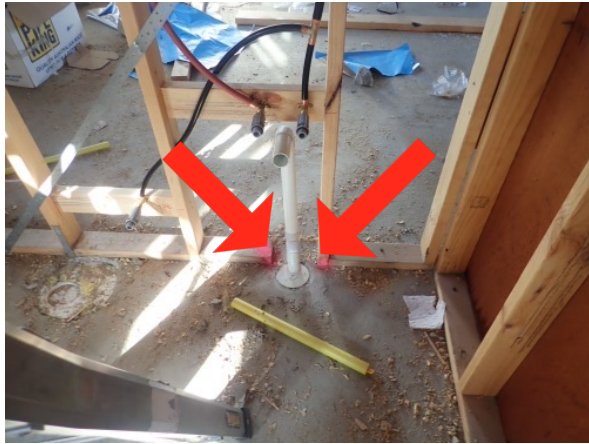
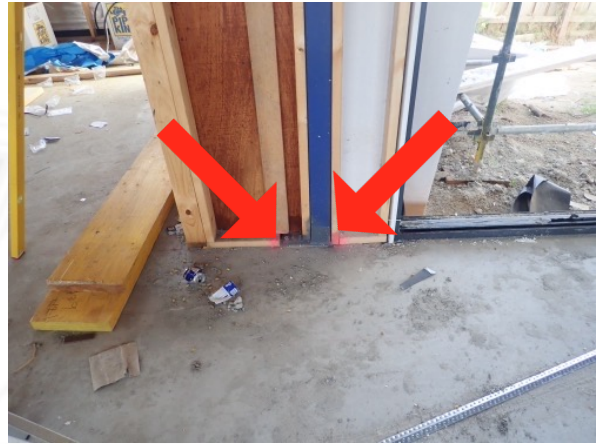
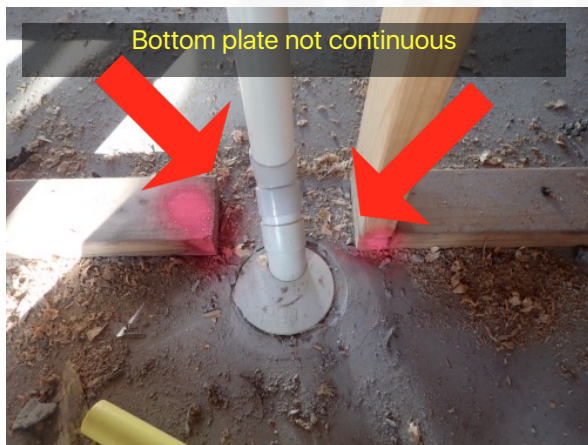
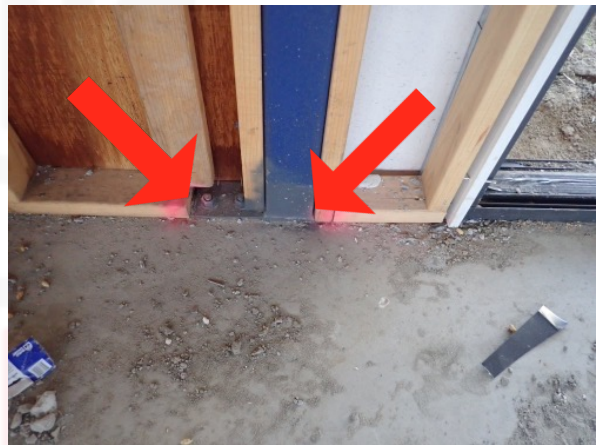
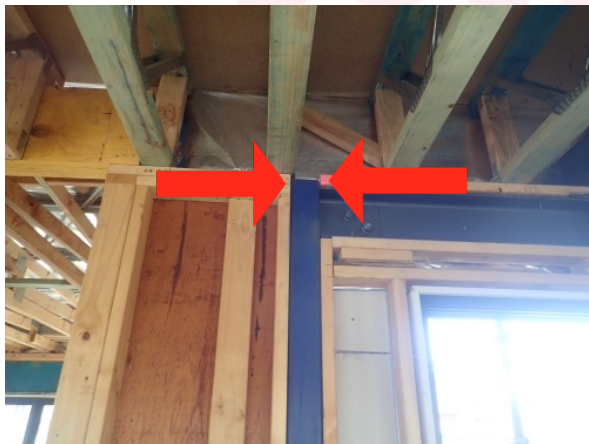
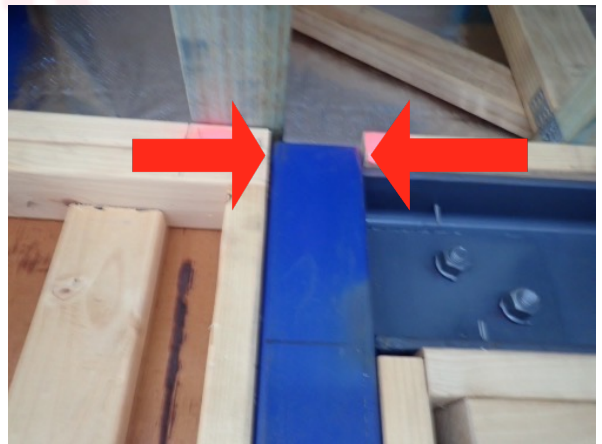
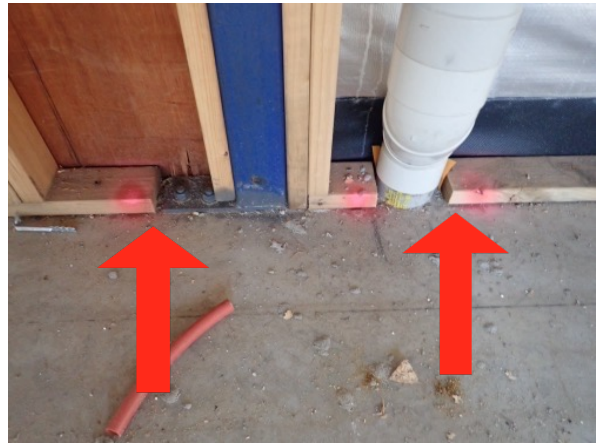
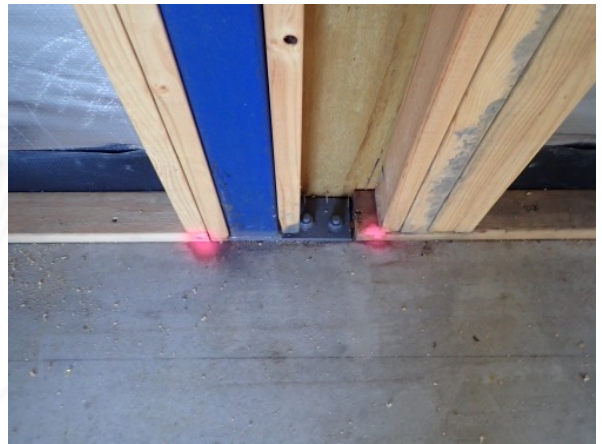
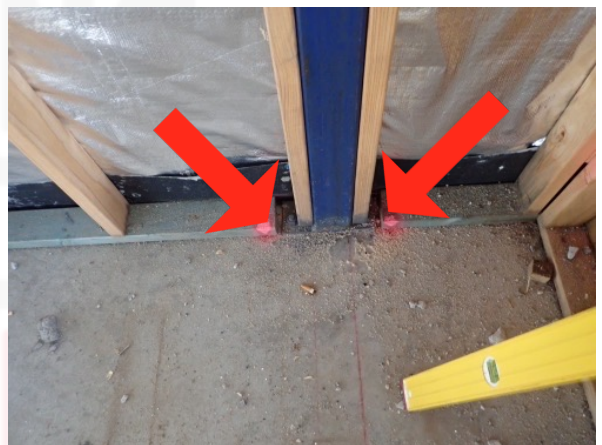
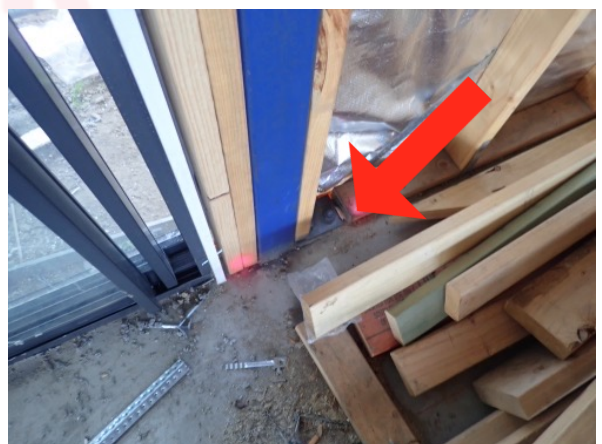
Non Compliant 2.01

Plates not continuous - Notched

AS 1684 Residential Timber Framed Construction, Section 6.2.1.4; Top And bottom plates in internal non-load bearing and non-bracing walls may be discontinuous up to 60mm (cut or drilled) to permit installation of services provided that, at the discontinuity, the plates are trimmed or otherwise reinforced either side of the discontinuity to maintain the lateral and longitudinal integrity of the wall (metal strap/hoop iron strap running past the discontinued plate by 150mm in both directions and nailed with flat head nails will suffice).

Any penetrations exceeding this or not conforming with this standard is therefore considered defective. This requires rectification by the builder prior to plasterboard being fitted to the walls.

Photographic evidence is to be provided to the building consultant of rectified works prior to the next stage commencing.

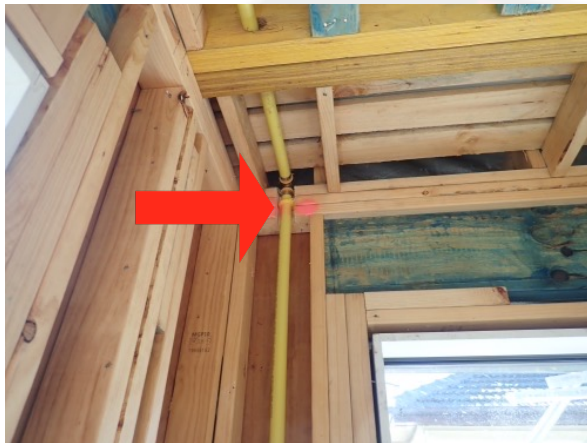
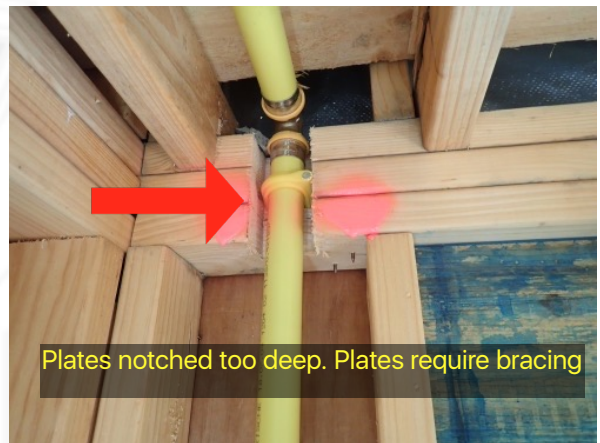
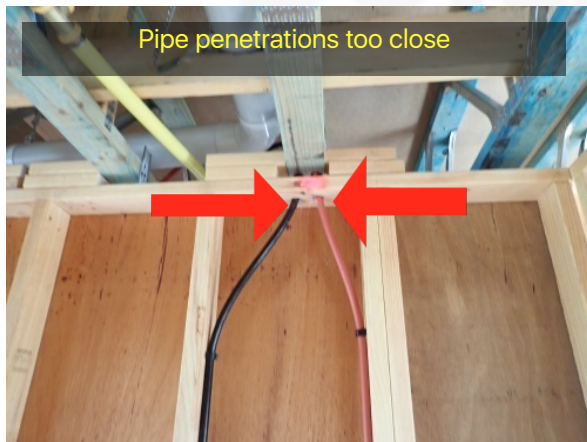
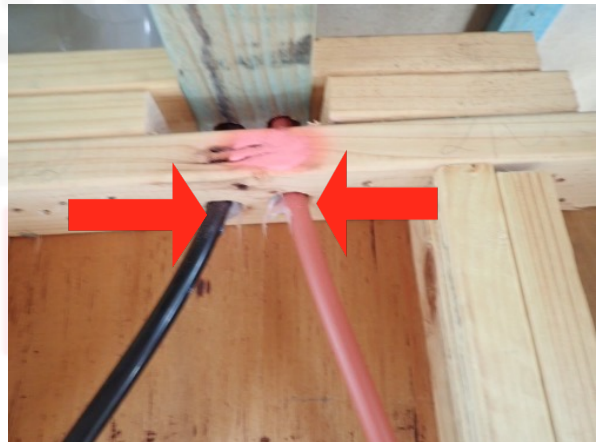
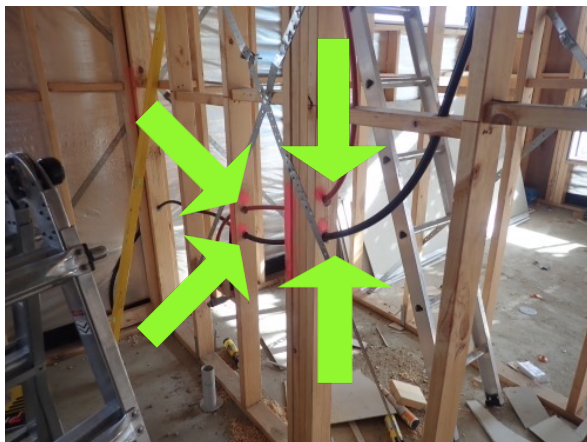
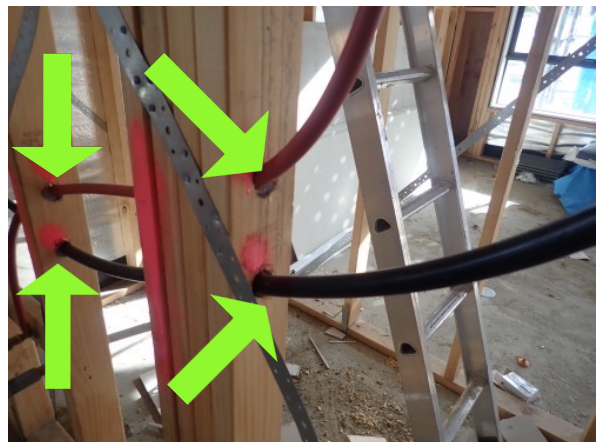
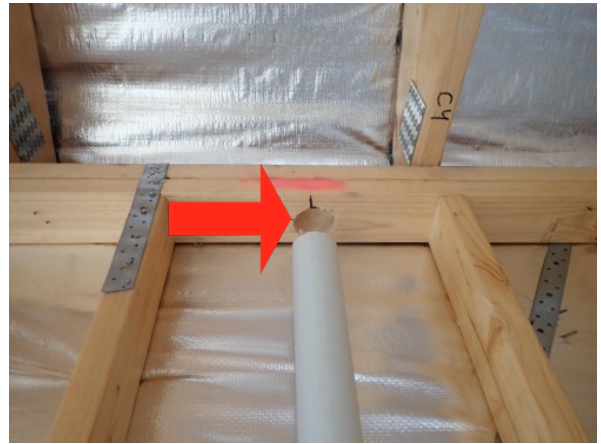
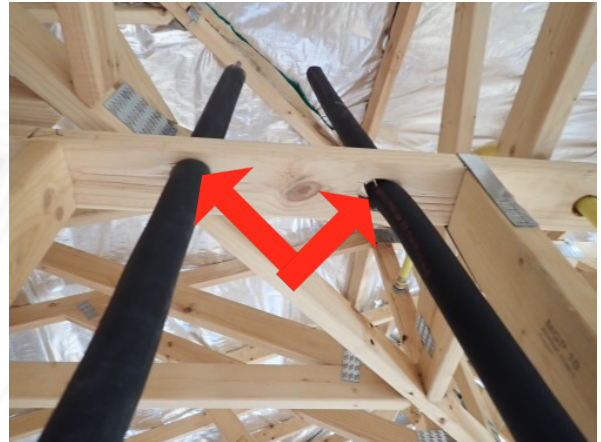
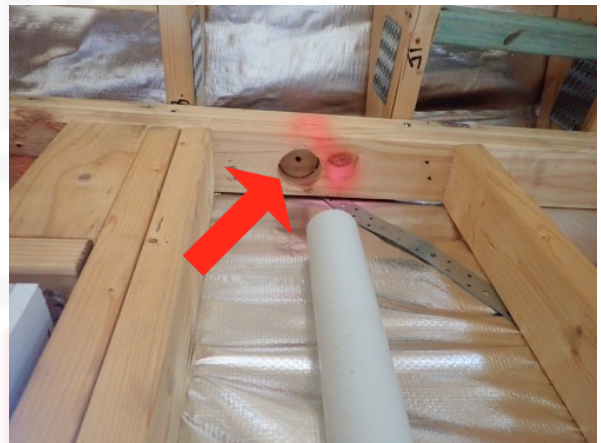
Non Compliant 2.02

Finding: Service holes and notching - insufficient distance

It was observed during inspection that the minimum distance between holes for services (electrical and / or plumbing) and notching has not been maintained. The AS1684 requires a minimum distance between holes and notching in a 90mm stud and top plates is 270mm. The standard states that the distance between holes and other holes or holes to notches in studs can be no closer than $3 \times D$. This is calculated as $3 \times$ the depth of the material used. In this case $3 \times D$ is $3 \times 90\text{mm}$ or 270mm minimum distance apart.

These plates and studs require additional strengthening prior to the next stage commencing. Flat steel strap (hoop iron strap) affixed using flat head nails, not screws, running past each penetration by minimum 150mm to both sides of the plate/stud will suffice.

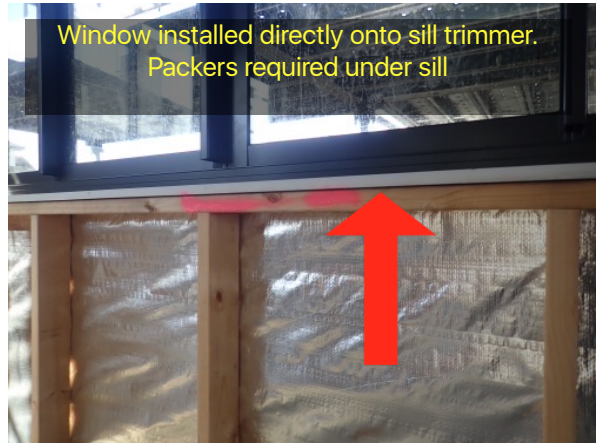
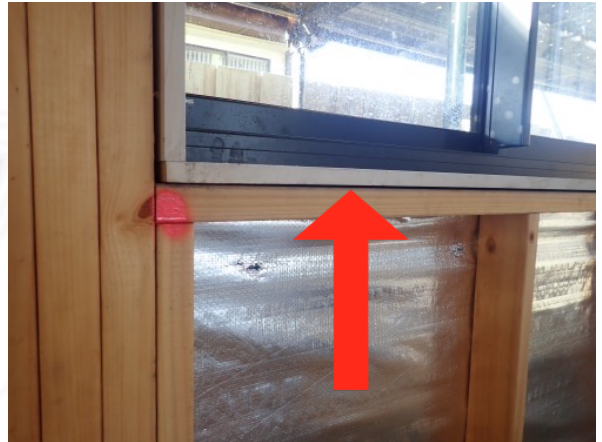
Non Compliant 2.03

Frame Openings for Windows - Incorrect

On inspection of the windows in the kitchen/family room area, it was noted that the windows in this have not been installed as per the manufacturers (A & L Windows) specifications, which specifies full width packers between the window sill and sill trimmer plate and a minimum spacing of 20mm between the top of the window frame and head trimmer.

No packers between sill and sill trimmer plate

Window installed directly onto sill trimmer. Packers required under sill

These windows require reinstallation as per the manufacturers specifications and AS 1684.4; clause 6.2.3.

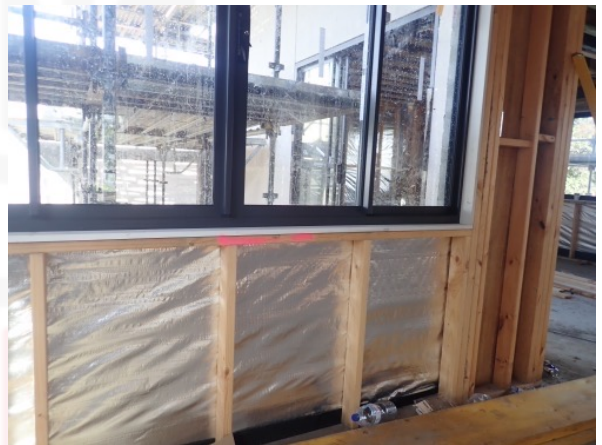
No packers

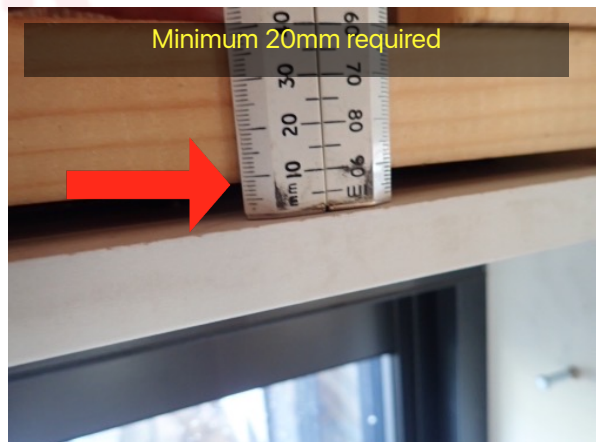
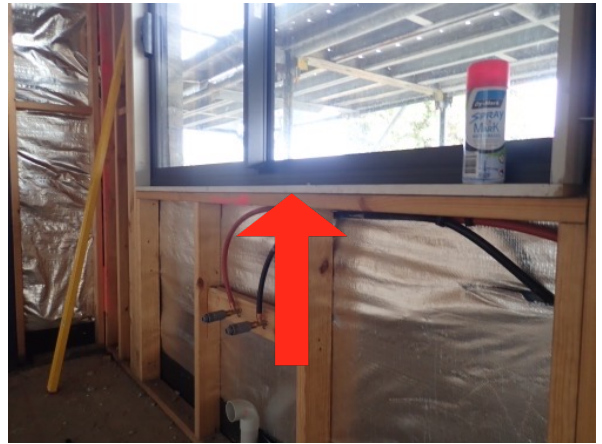
Insufficient gap between head and trimmer

Minimum 20mm required

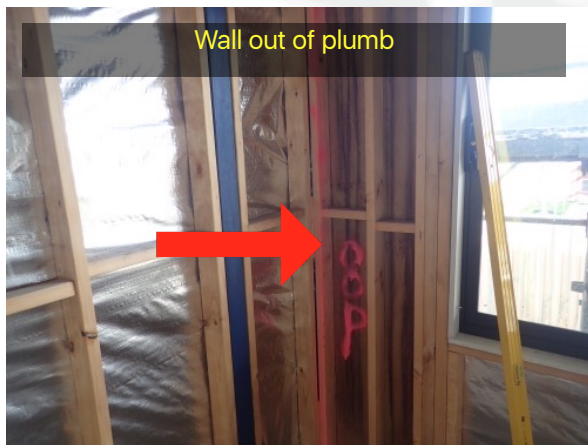
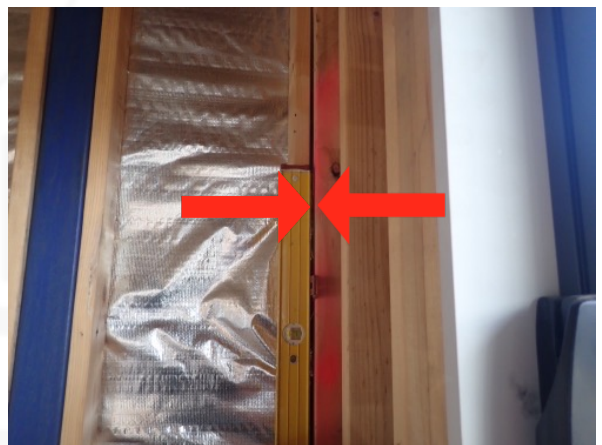
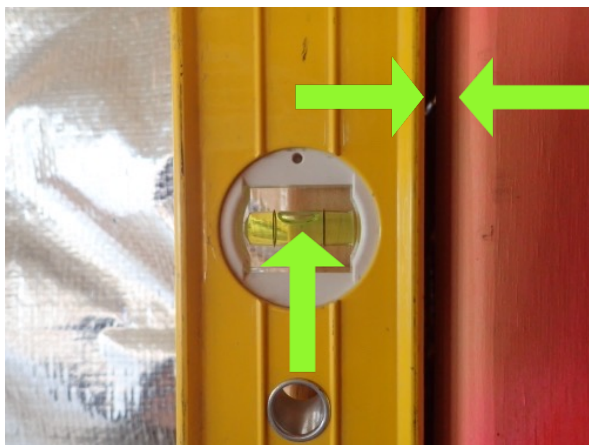
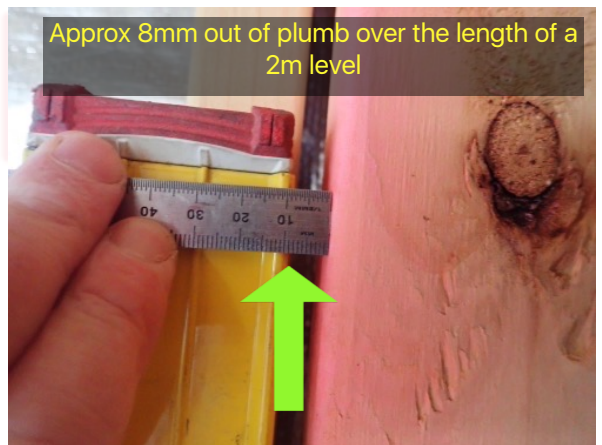
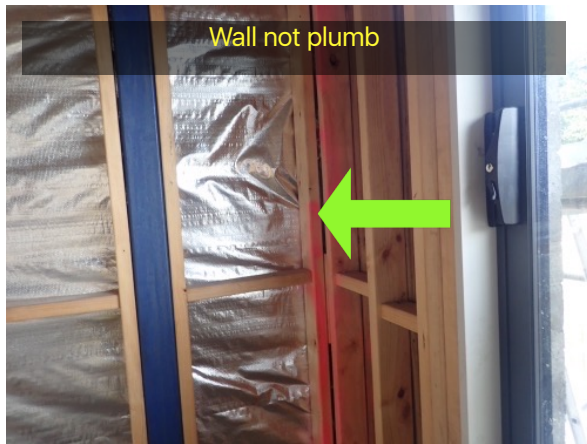
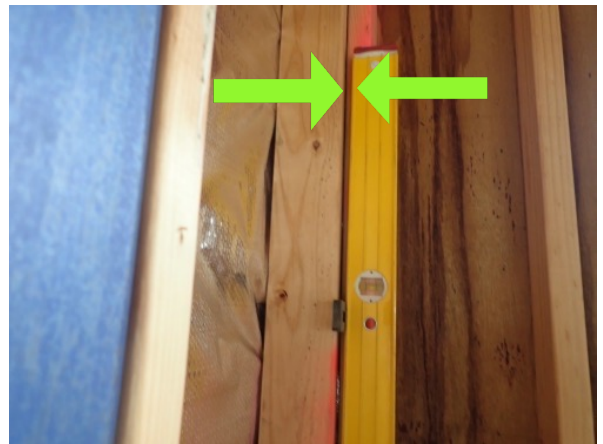
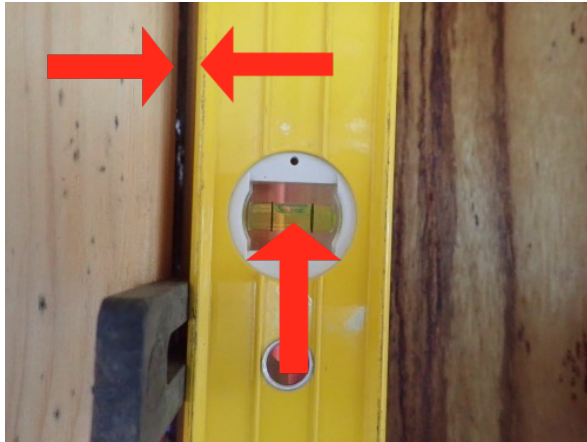
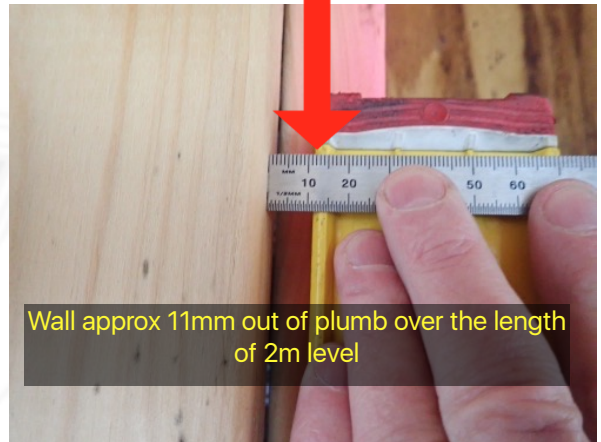
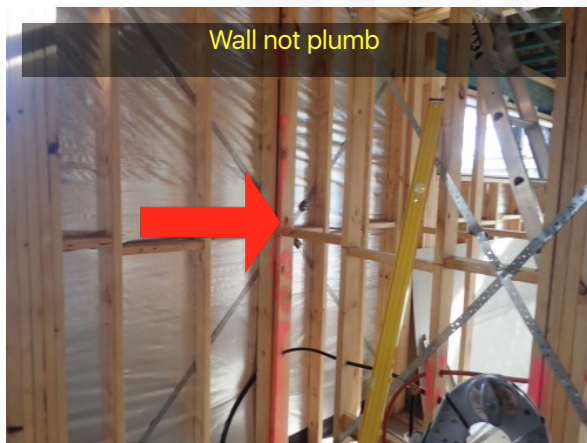
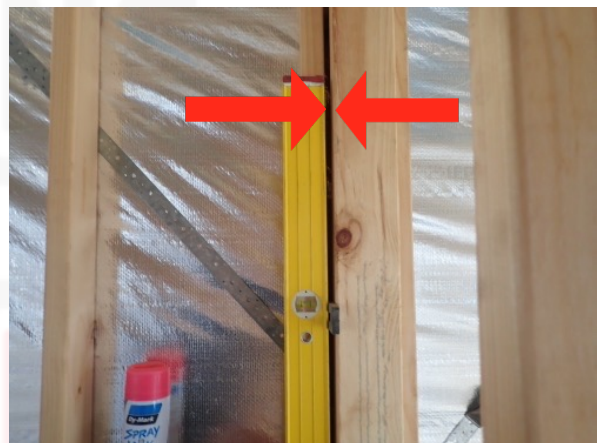
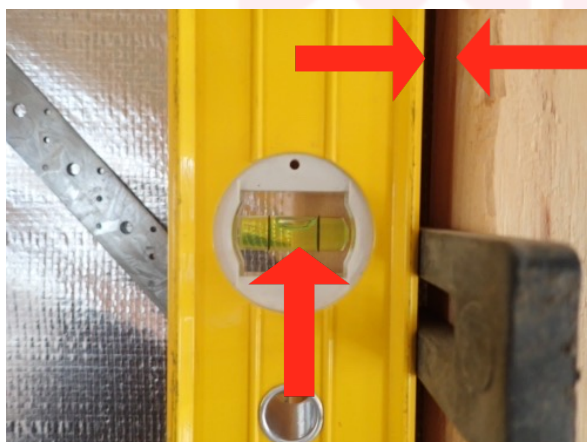
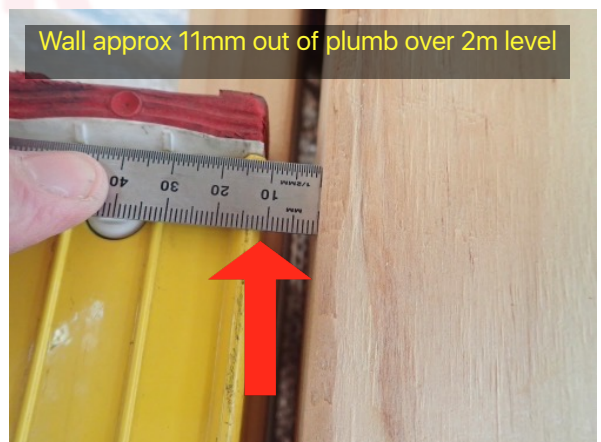
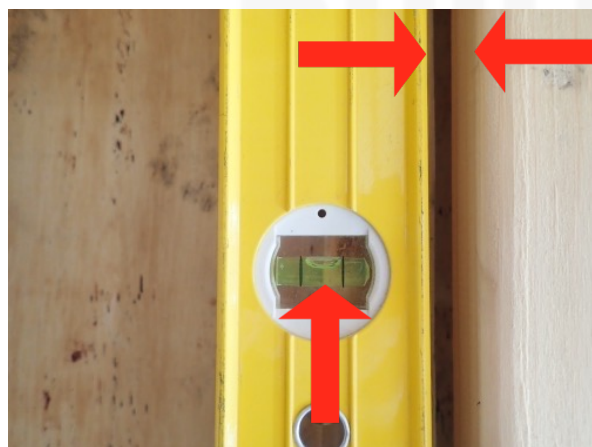
Non Compliant 2.04

Finding: Verticality or plumbness of steel and timber frames and exposed posts

Posts and wall frames are defective if they deviate from vertical by more than 5 mm over a 1.8 m height as per the Guide to Standards and Tolerances 2015.

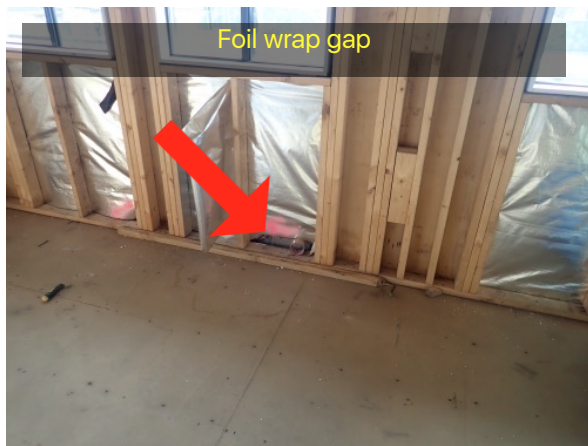
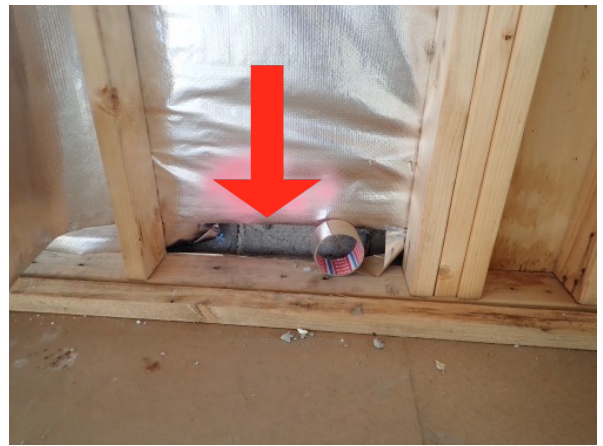
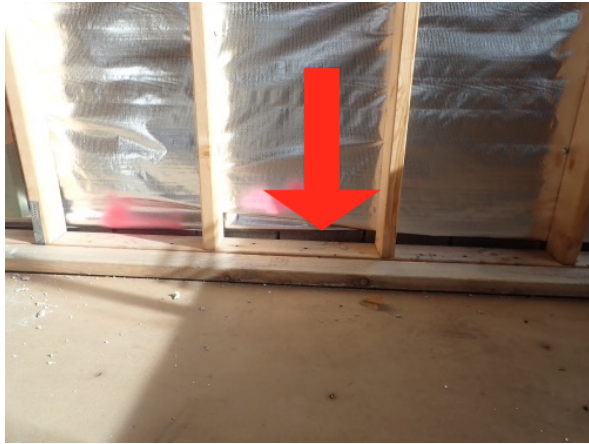
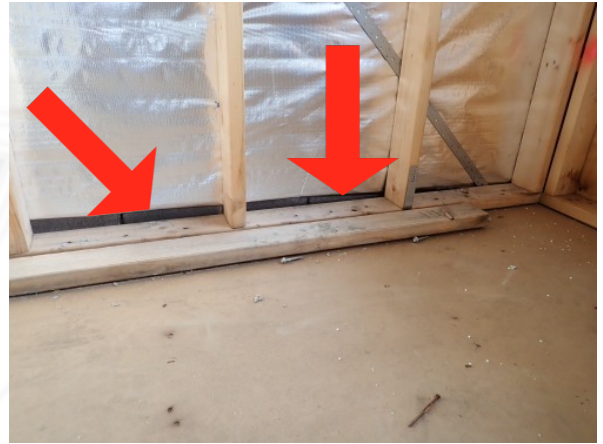
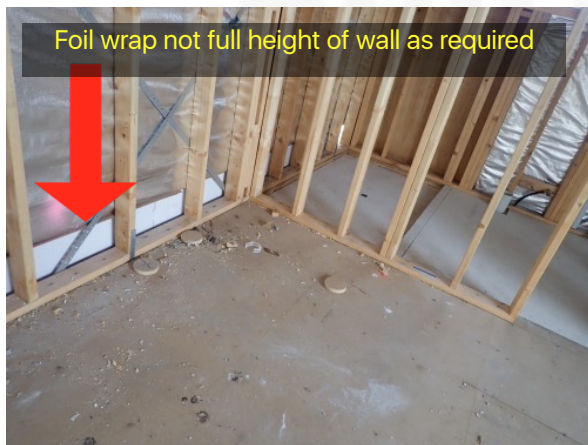
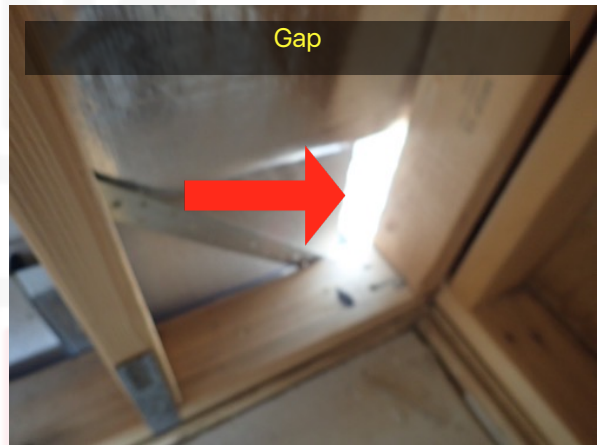
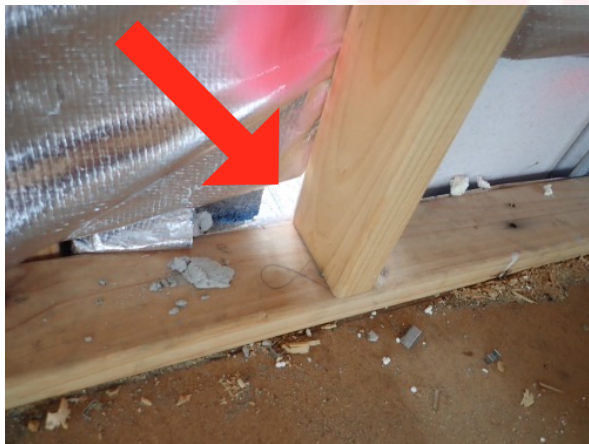
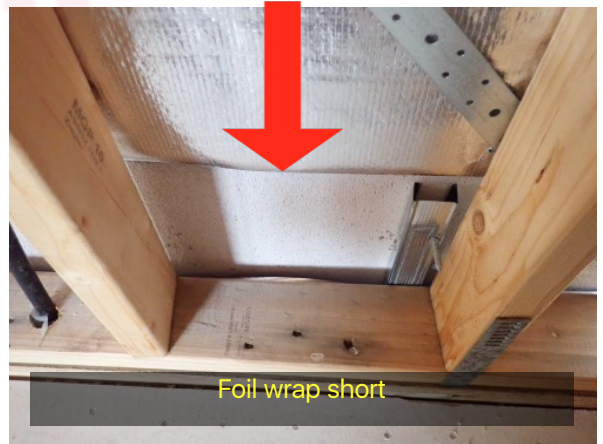
Non Compliant 2.05

Finding: Sarking/Foil Wrap - Suspected Non Compliance

The wall sarking/foil wrap was observed to have gaps and appeared to be installed non-compliant as per NCC volume 2; Table 3.5.4.2 requirements which state:

- (A) each adjoining sheet or roll being —
 - (aa) overlapped not less than 150 mm; or
 - (bb) taped together; and
- (B) sarking fixed to supporting members at not more than 300 mm centres.

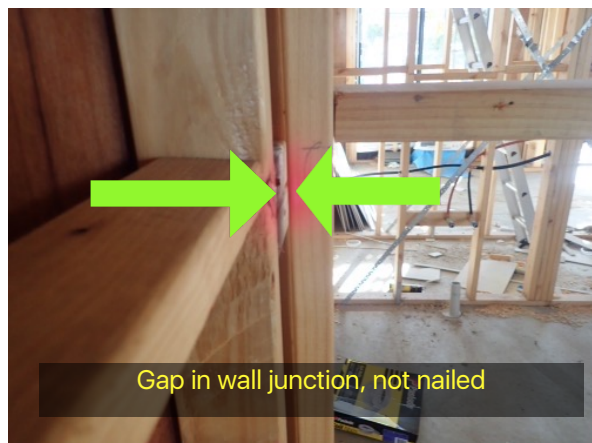
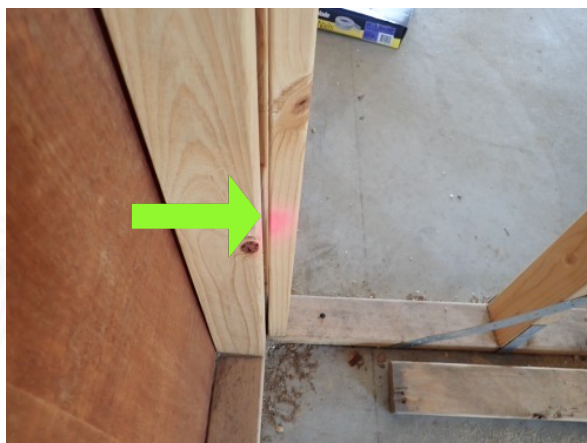
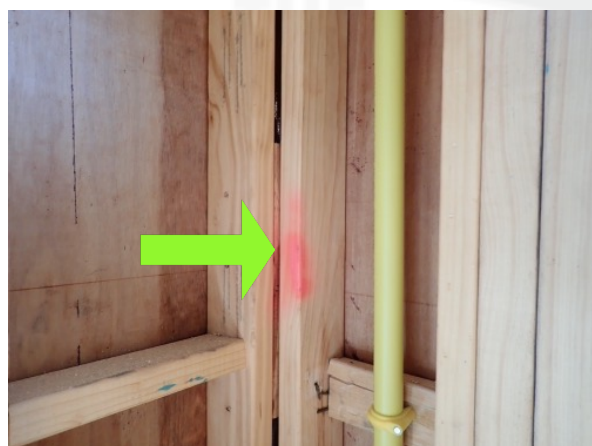
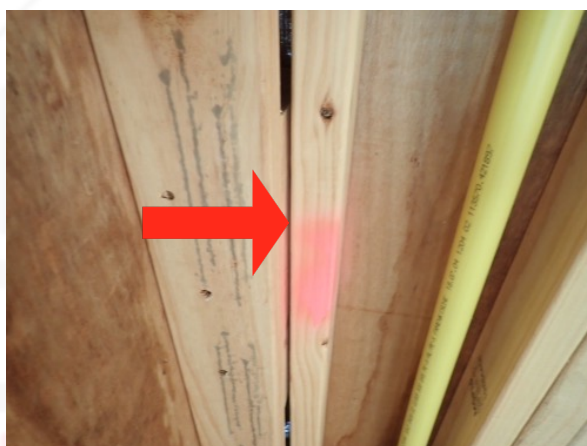
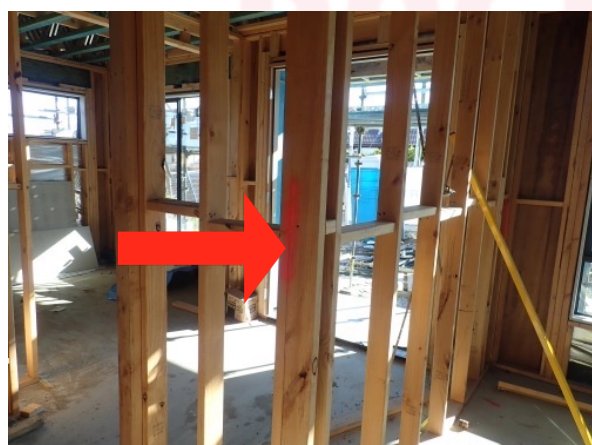
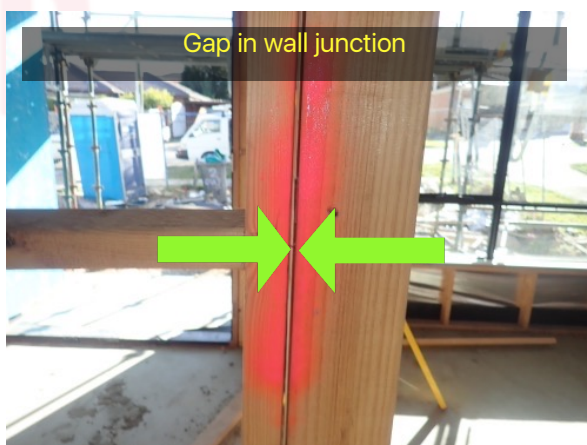
Non Compliant 2.06

Finding: Wall Junctions - Not Nailed Off

On inspection of the property, it was observed that many, if not all the wall junctions have not been nailed off required by AS 1684.4 Residential Timber Framed Construction.

This requires immediate rectification by the builder.

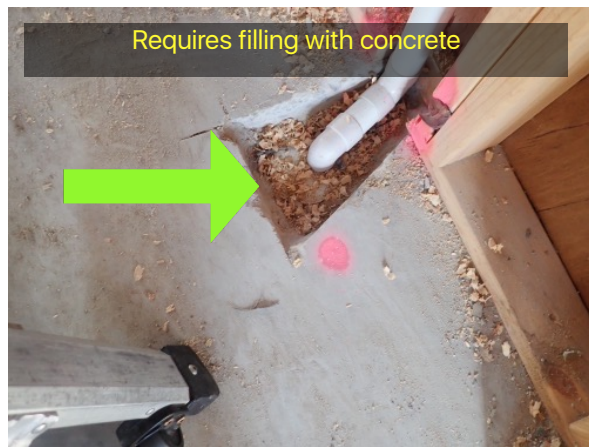
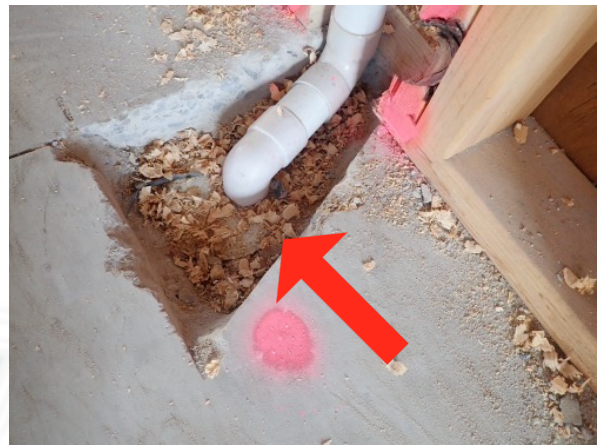
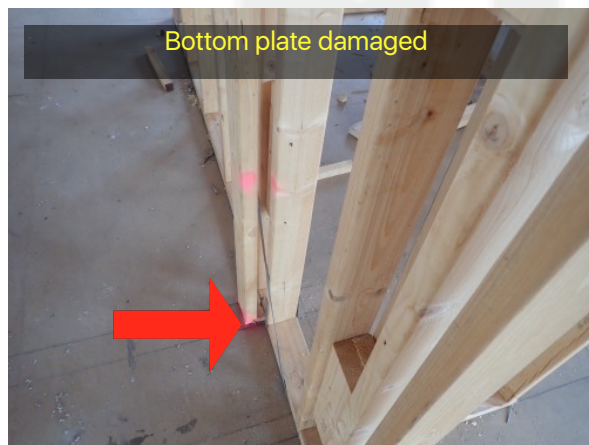
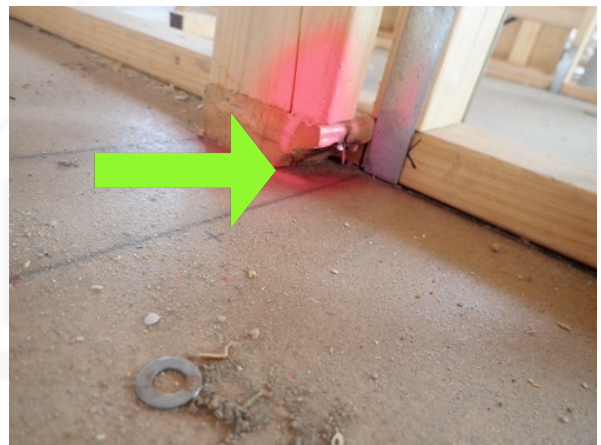
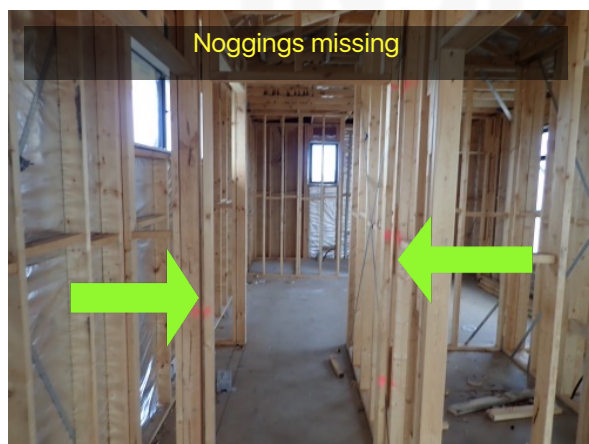
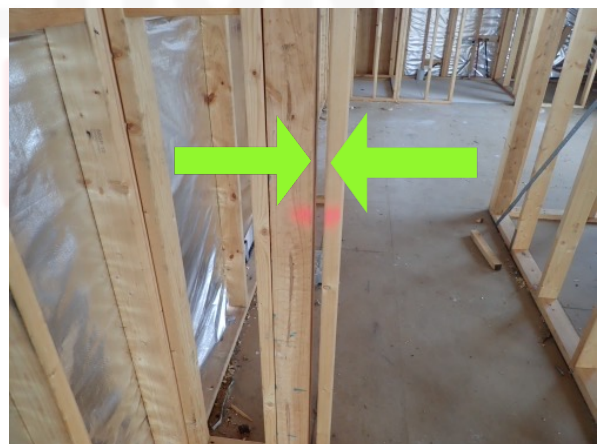
Substandard Workmanship 3.01

Finding: Additional Photos

Additional photos are provided for your general reference.
