Handover Stage Inspection Report

Inspection Date: 5 Jun 2025

Building Type:	Townhouse
Storeys:	Two storey
Siting of the building:	Towards the front of a large block
Gradient:	The land is sloping
Site drainage:	The site appears to be adequately drained
Orientation of the property:	The facade of the building faces south Note. For the purpose of this report the façade of the building contains the main entrance door.
Weather conditions:	Overcast

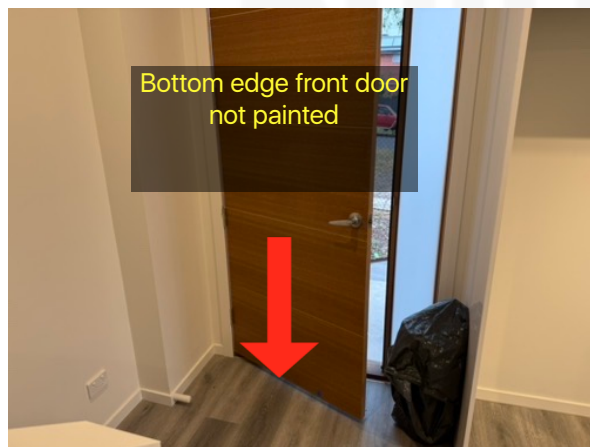
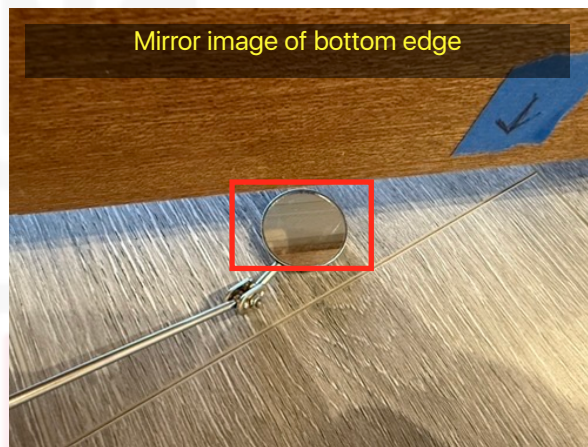
Non Compliant 1.01

Location: Front Entry

Finding: Door edge sealing - defective

It was observed that the top and bottom edges of the external and wet area doors have not been painted.

All edges of external and wet area doors must be sealed to prevent moisture ingress and to comply with Standards and Tolerances and the door manufacturers specifications.

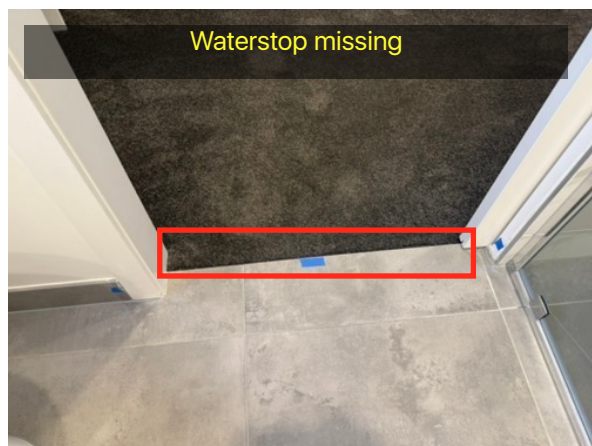
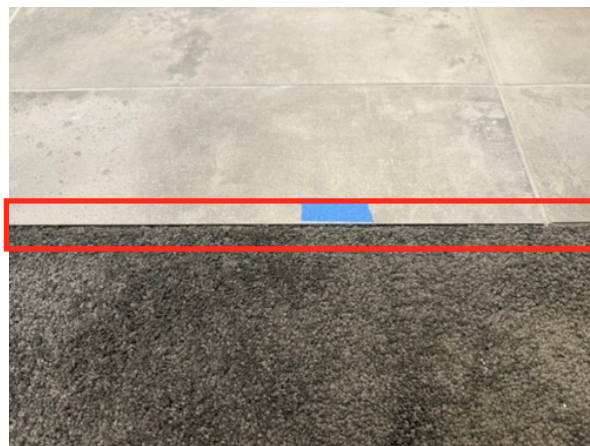
Non Compliant 1.02

Location: Ensuite

Finding: Wet Areas Waterstop Required

On inspection of the ensuite, it was noted that the floor tiles have been installed higher than the aluminium doorway edge strip, or waterstop. This is considered non-compliant as per AS 3740 Waterproofing of Domestic Wet Areas: 1.3.42 which stipulates that a waterstop is required, which is a vertical extension of the waterproofing system forming a barrier to prevent the passage of moisture into the floor or vertically in a wall.

A waterstop is required to prevent moisture from penetrating the carpet and/or entering other rooms. A waterstop must be fitted at the bathroom doorway to be considered compliant with AS 3740.

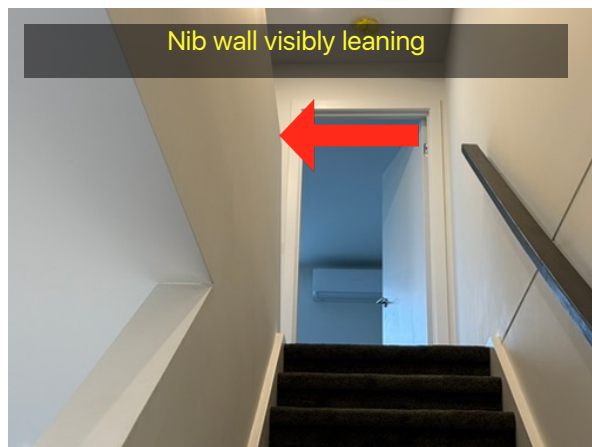
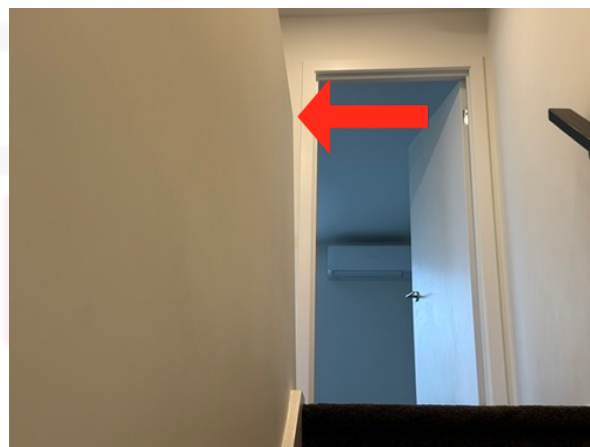
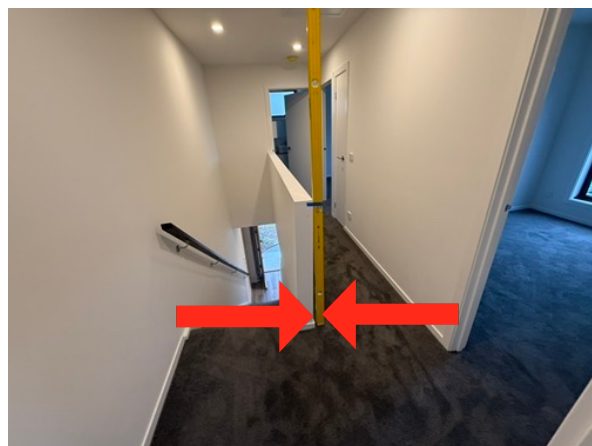
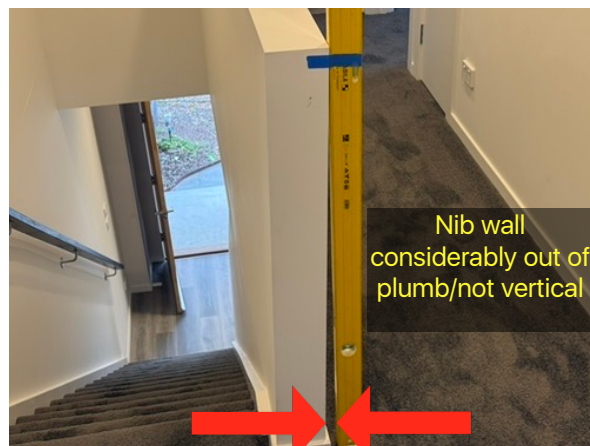
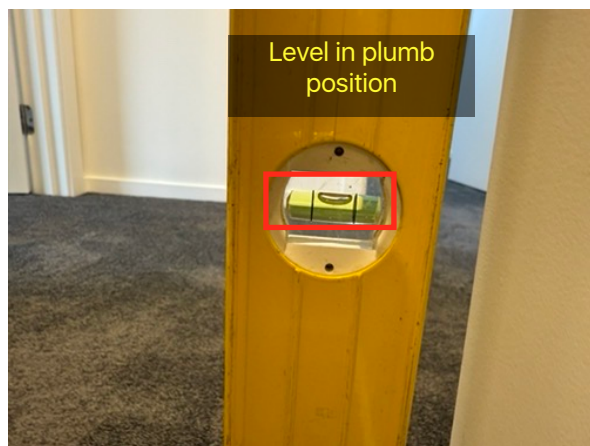
Non Compliant 1.03

Location: Upper Storey Hall

Finding: Nib Wall - Not Plumb

The nib wall located at the top of the stairs, was noted to be leaning considerably. Upon placing a level on the edge of the nib wall, it measured approximately 31mm out of plumb, which is considered extreme.

As stipulated in 'The Guide to Standards and Tolerances 2015 Clause 9.10 Verticality or Plumbness of Internal Wall Surfaces'; Wall surfaces are defective if they deviate from vertical by more than 4mm within any 2m height.

The nib wall is approximately 1050mm in height and deviating 31mm from vertical.

The builder is required to rectify this prior to final handover to the client.

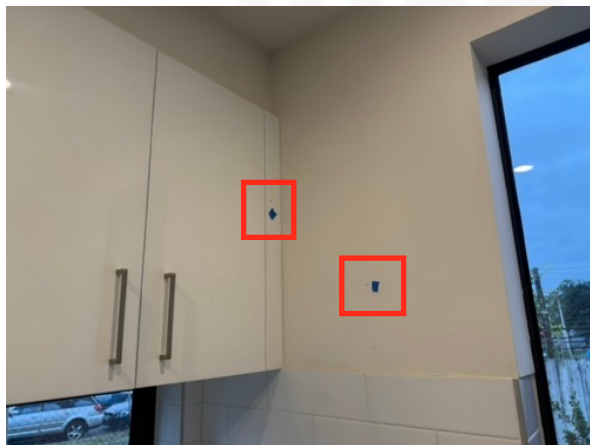
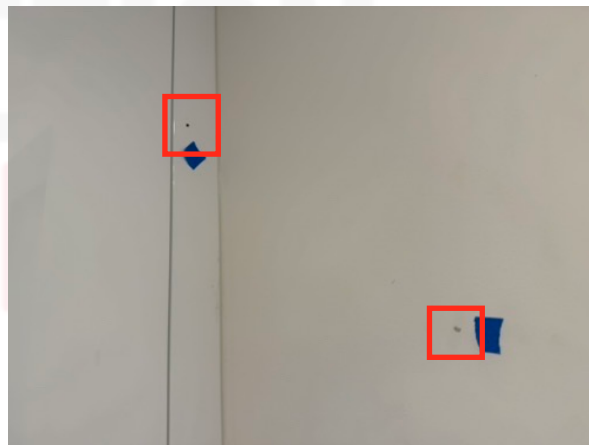
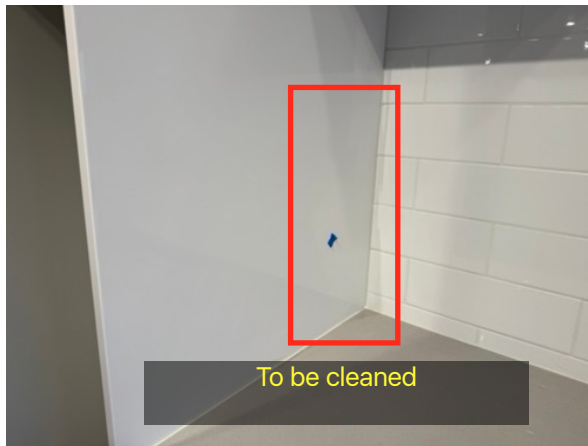
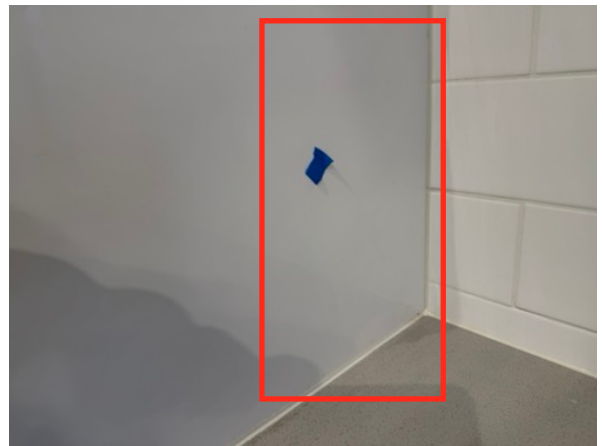
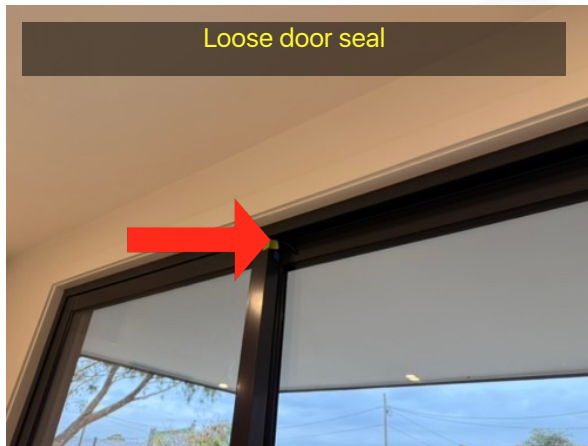
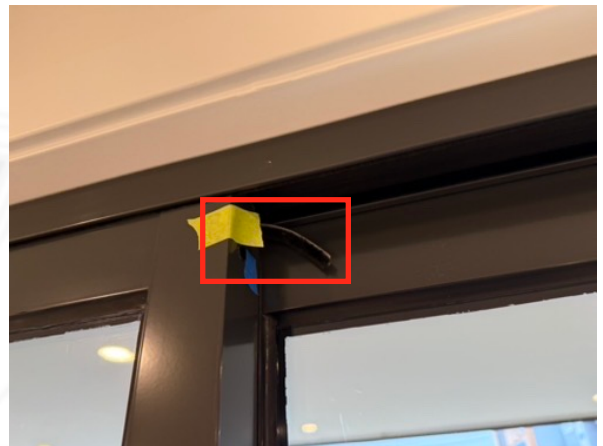
Non Compliant 1.04

Location: All areas

Finding: Incomplete/Substandard Construction

There are a number of Building elements that were identified as being incomplete or substandard works. Substandard and incomplete work are determined by identifying a failure to achieve the minimum requirement set out in the mandated Australian Standard as outlined in the Building Code of Australia and referenced by the Manufacturers Guideline. Reference and clarification can also be made to the Guide to Standards and Tolerances for simplification.

Where a building element is installed in such a way that it fails to achieve the required minimum standard or level of finish at the time of the inspection, the builder needs to rectify the defect as soon as possible and complete works to the required standard.

All known defects need to be rectified prior to final handover to the client.

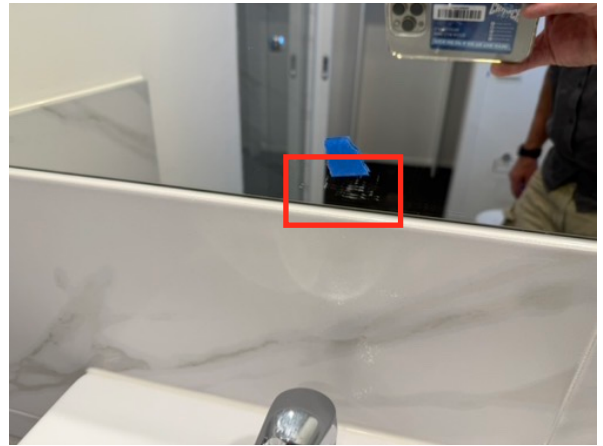
Shoddy finish

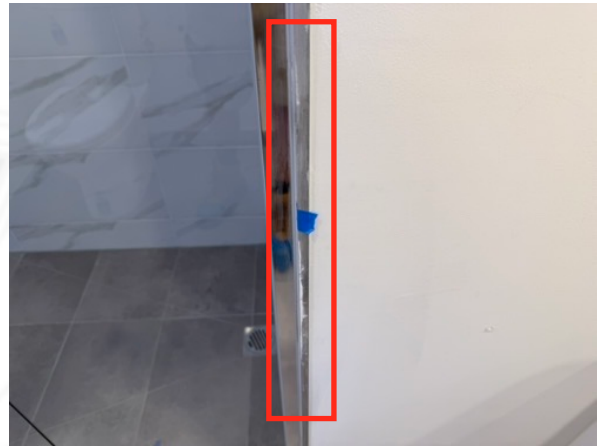
Paint drips

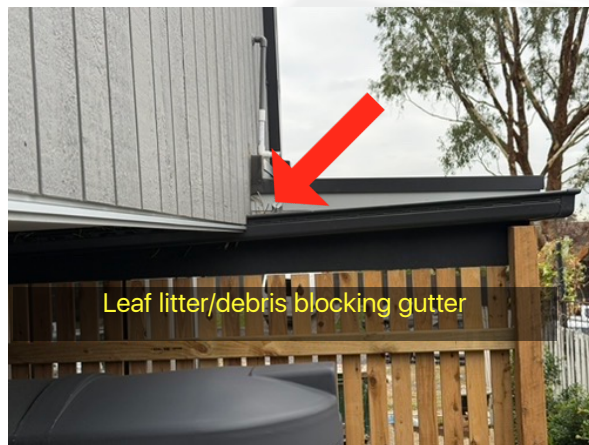
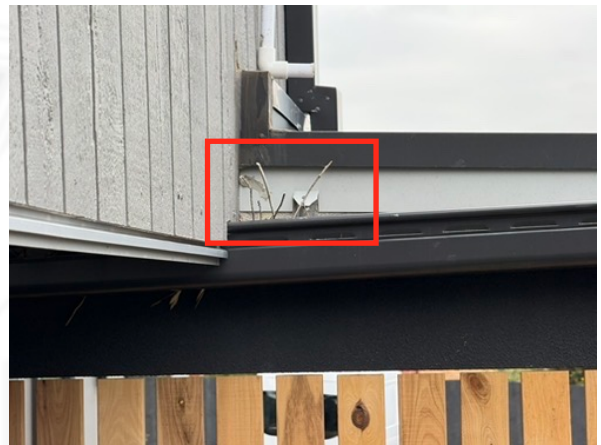
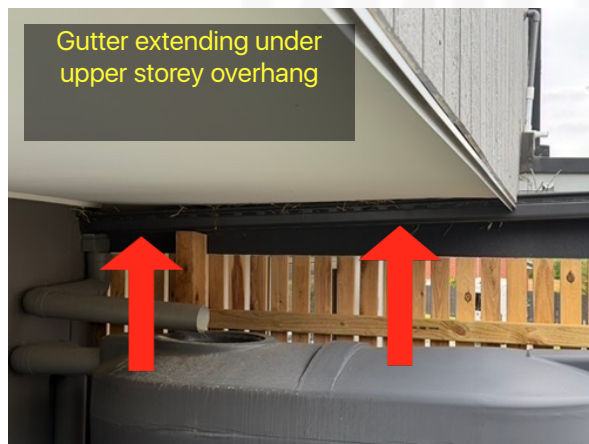
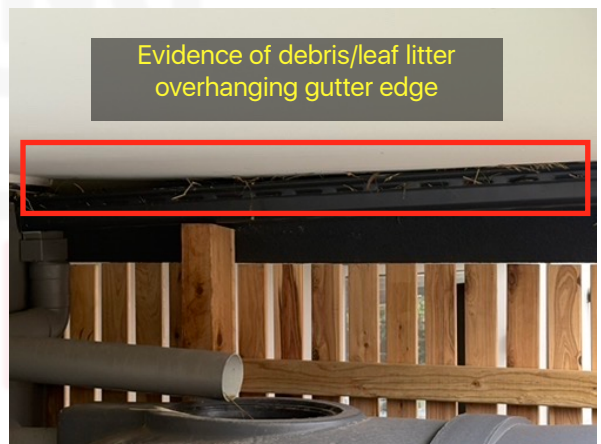
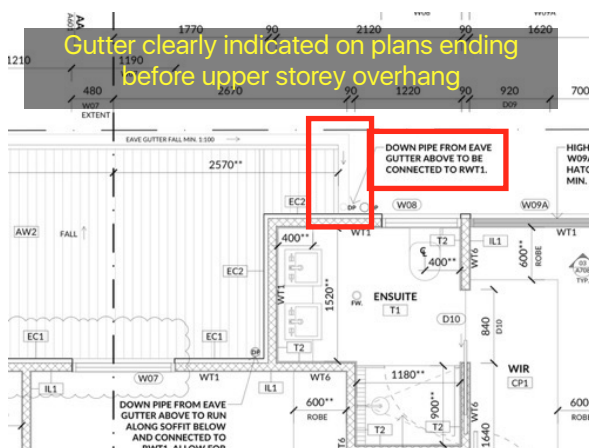
Non Compliant 1.05

Location: Rear Elevation

Finding: Gutter Blocked & Inaccessible

It was noted that the gutter at the rear of the eaves, has been installed hard-up to the underside of the upper storey overhang, and therefore inaccessible for the purpose of unblocking any debris or leaf litter when required. At the time of inspection, the gutter was observed to be jammed with leaf litter and unlikely to be draining stormwater freely as per AS 3500 Plumbing and Drainage requirements.

Upon reviewing the stamped plans, this gutter is shown to stop before the upper storey overhang, with a downpipe connection from this point running into the rainwater tank.

This requires rectification by the builder prior to final handover to the client.
