# Handover Stage Inspection Report

Inspection Date: 5 Jun 2025

Building Type: Townhouse

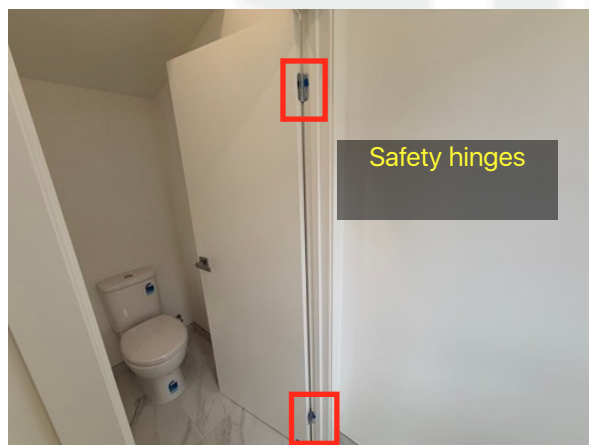
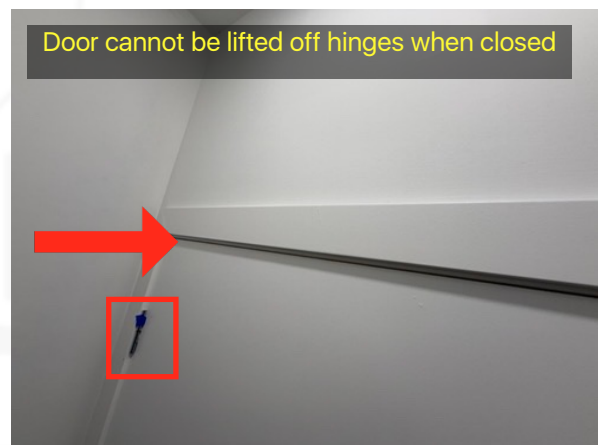
### Safety Hazard 1.01

**Location:** Powder Room

**Finding:** Door Safety Hinges

It was noted that the toilet door cannot be lifted off the safety as required, due to not enough space between top of door and head of door jamb for the door to be lifted off the hinges.

As it is a requirement that the door can be lifted off the hinges when closed for the health and safety of the occupants of the property, the door must be properly installed by the builder to comply with NCC - 3.8.3.3 Construction of sanitary compartments.

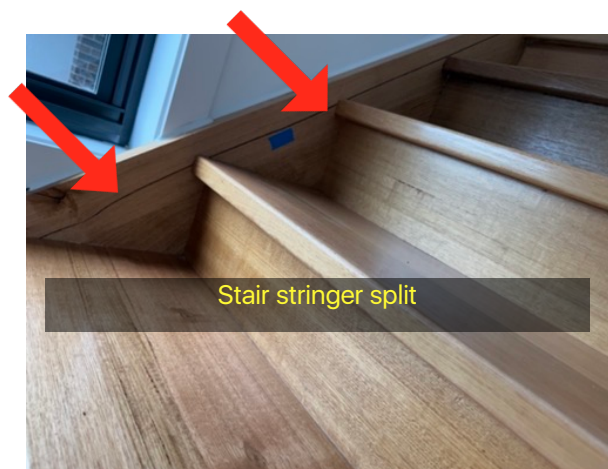
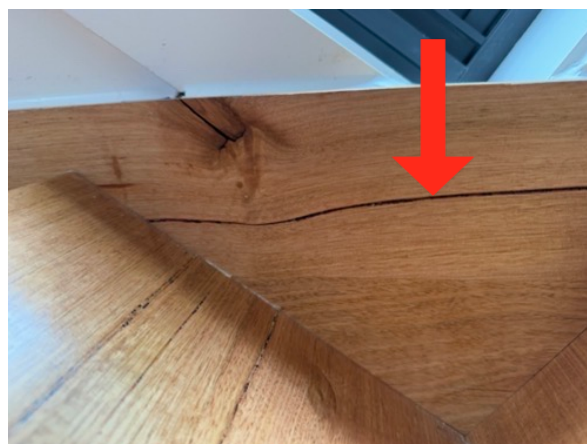
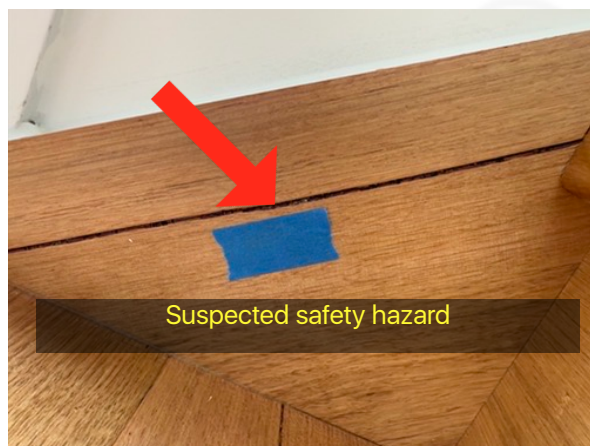
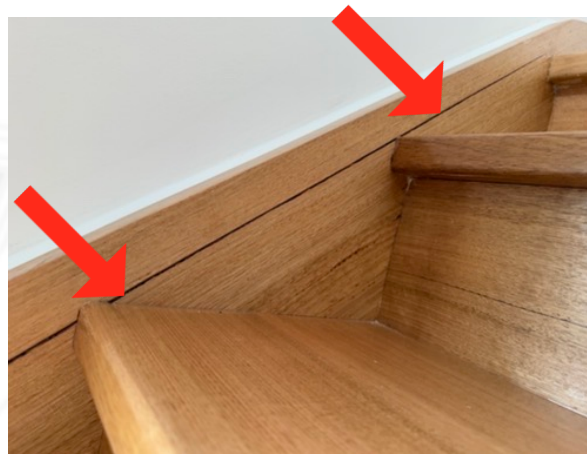
### Safety Hazard 1.02

**Location:** Stairs

**Finding:** Stair Stringer Split

It was noted when alighting the stairs, that the left side stringer is splitting, which could potentially be affecting the structural stability of the staircase.

Urgent appointment of the stair manufacturer and/or a structural engineer is required to immediately inspect and assess the structural integrity of the stairs.

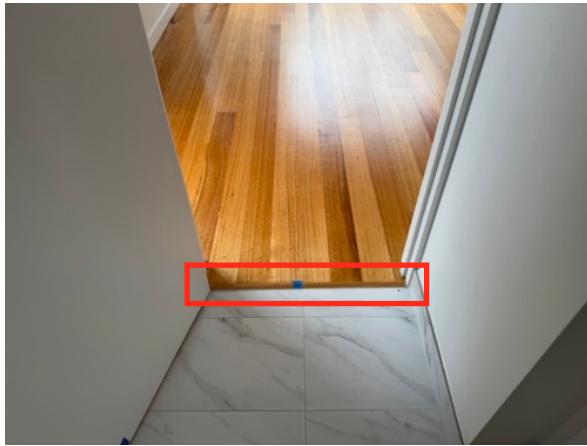
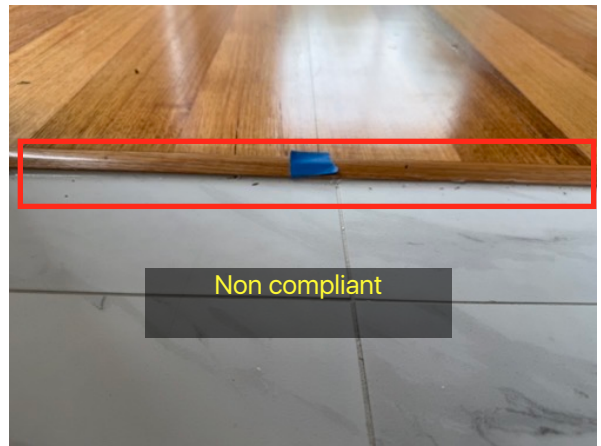
## Non Compliant 2.01

**Location:** Laundry

**Finding:** Waterstop Required

On inspection of the downstairs laundry, it was noted that the finished floor level of the timber flooring is currently considerably higher than the finished floor tile level in the wet areas. This is not only a potential trip hazard, but is considered non-compliant as per AS 3740 Waterproofing of Domestic Wet Areas: 1.3.42 which stipulates that a waterstop is required, which is a vertical extension of the waterproofing system forming a barrier to prevent the passage of moisture into the floor or vertically in a wall.

The bevelled edged length of timber that is currently in position of where the waterstop is required, is not vertical and timber cannot be used as part of a waterproofing barrier.

A waterstop is required to prevent moisture from penetrating the timber flooring. The timber flooring should be lowered to the same height or lower than the floor tiles in the wet areas and a waterstop fitted at the doorways to be considered compliant with AS 3740.

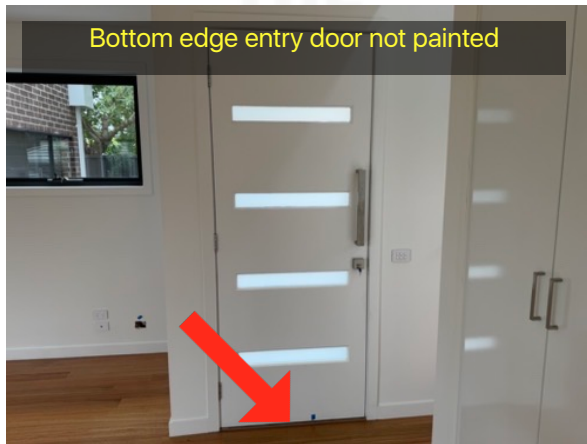
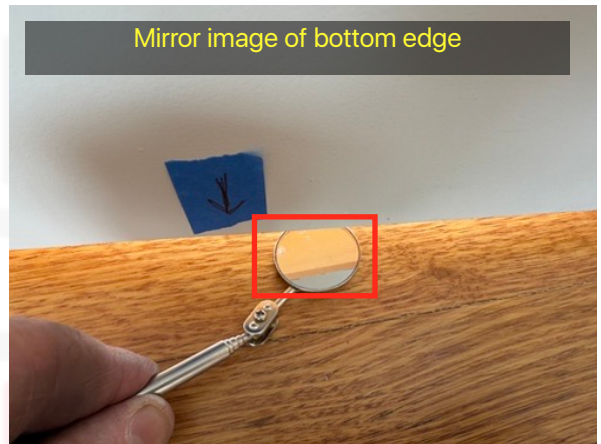
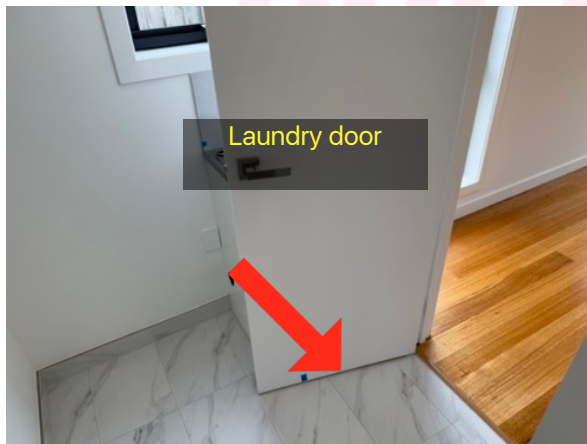
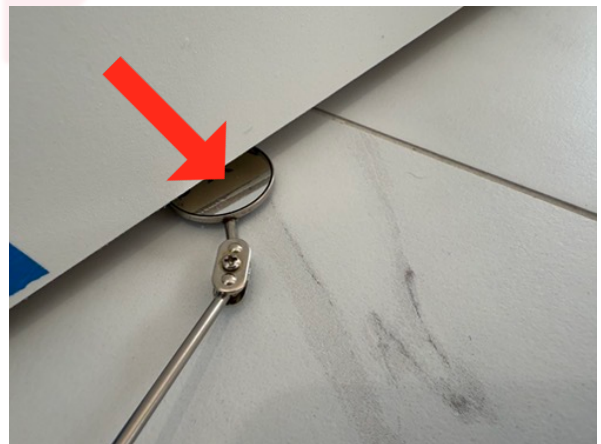
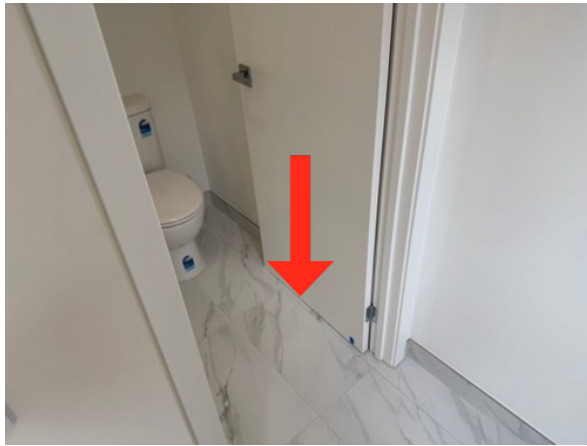
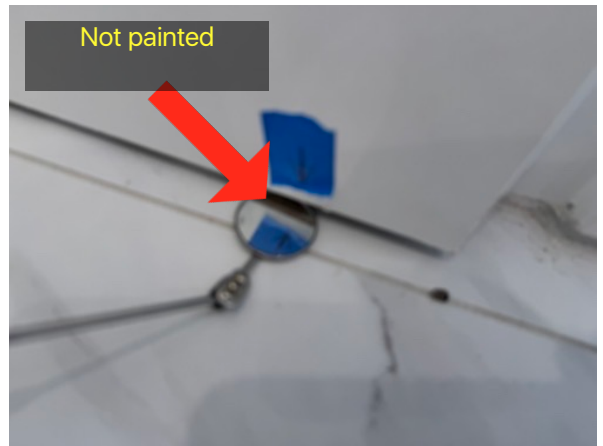
## Non Compliant 2.02

**Location:** Entry & Wet Areas

**Finding:** Door edge sealing - defective

It was observed that the top and bottom edges of the external and wet area doors have not been painted.

All edges of external and wet area doors must be sealed to prevent moisture ingress and to comply with Standards and Tolerances and the door manufacturers specifications.

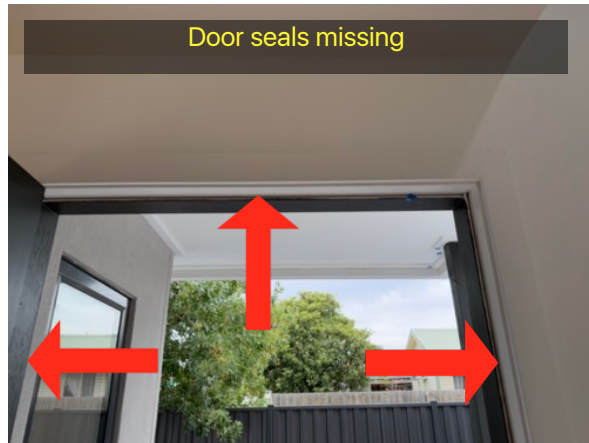
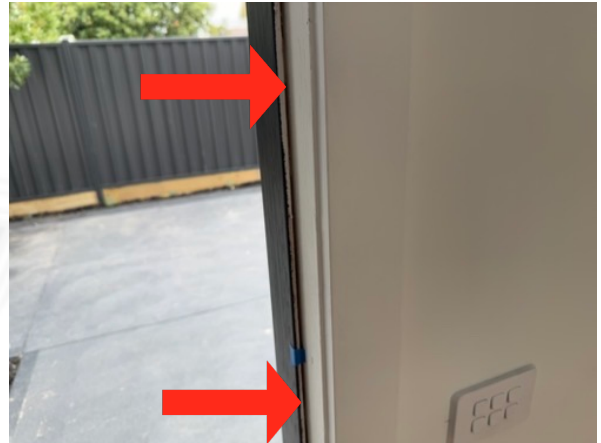
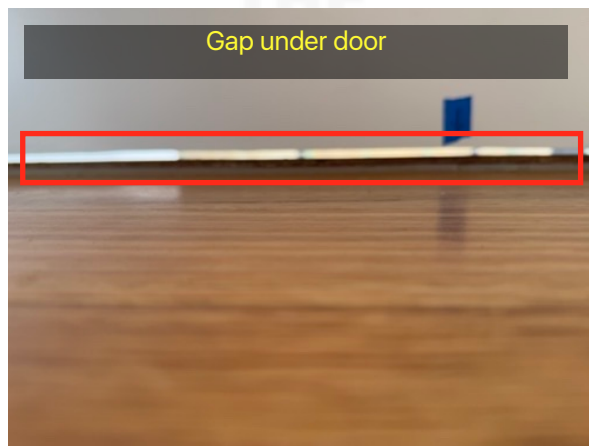
## Non Compliant 2.03

**Location:** Front Entry

**Finding:** Doors (external) - Gaps and / or seals defective

It was identified that external door/s are not fully sealed to all edges. This requirement is inclusive of the garage to house entry door which must have full weather seals fitted to comply with the BCA part 3.12.3.3 and to obtain the six star energy rating required for newly constructed homes.

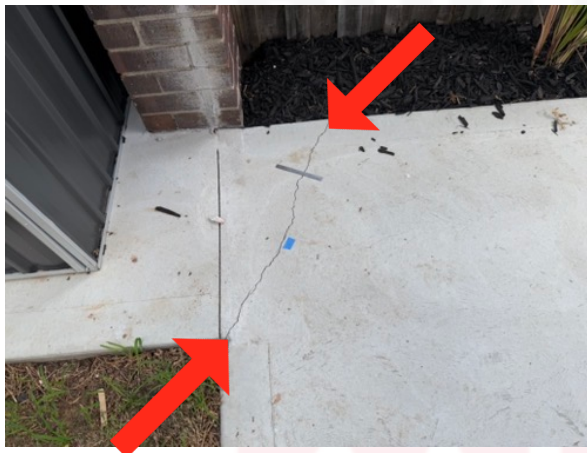
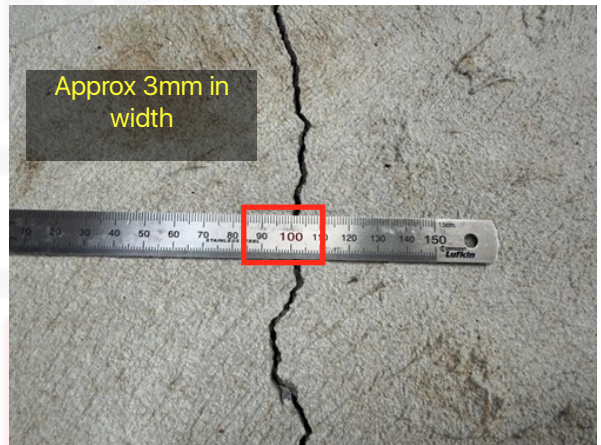
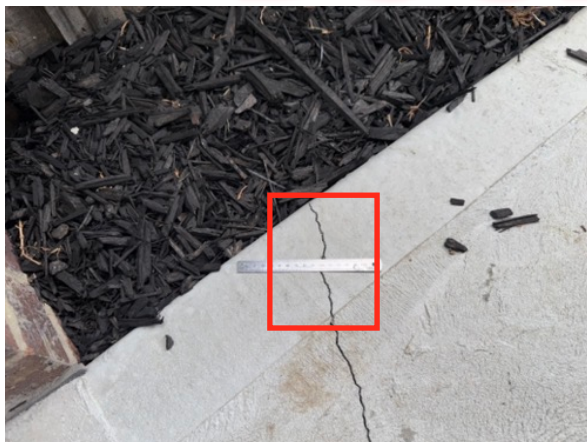
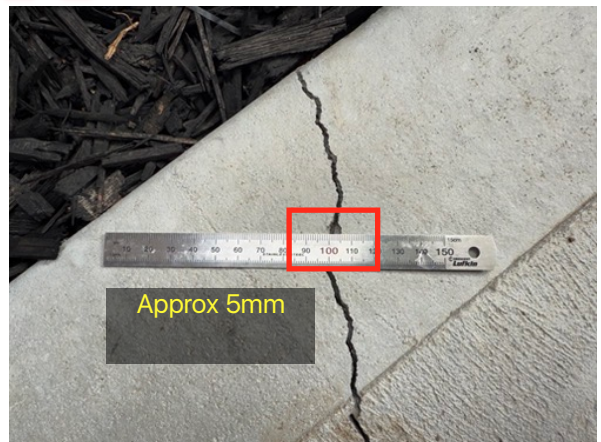
## Non Compliant 2.06

**Location:** Carport

**Finding:** Category 2 cracks in carport concrete slab

Distinct cracking was observed in the carport slab at the time of inspection. These cracks were assessed as Category 2 as per table 2.10 of The Guide to Standards and Tolerances 2015.

Category 1 and 2 cracks to slabs are to be monitored for a period of 12 months. At the end of the monitoring period, cracks are defective if they are greater than category 2 and attributed to the actions of the builder.

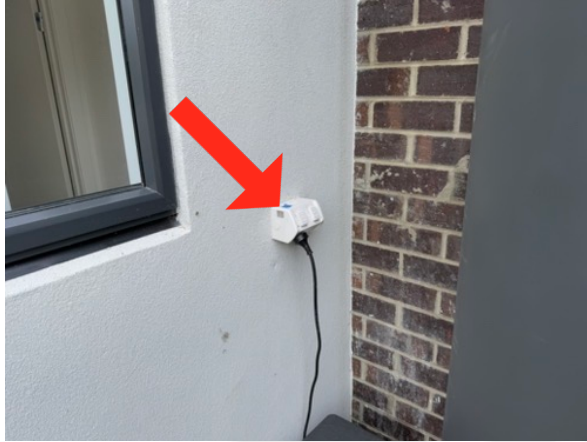
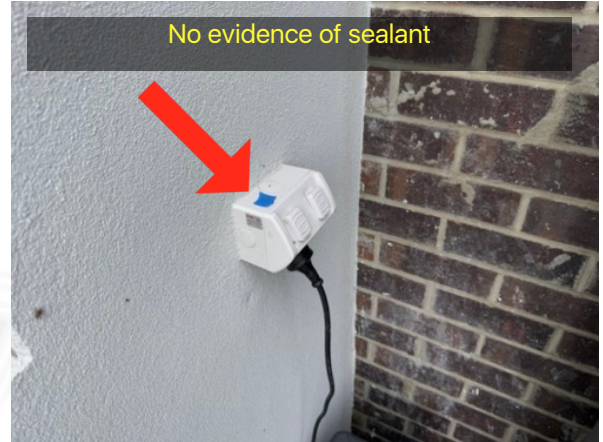
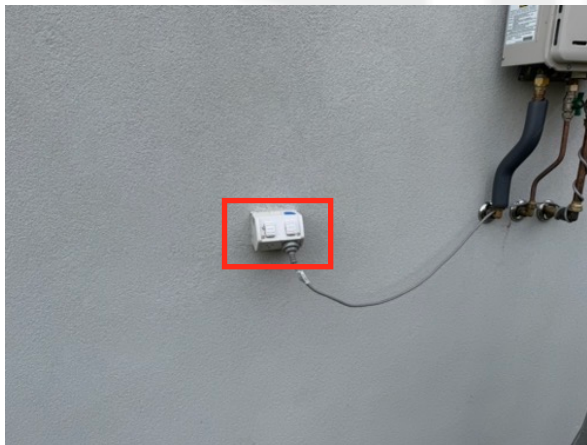
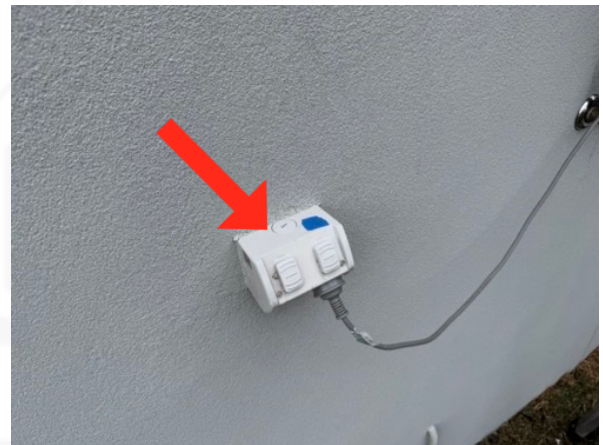
## Non Compliant 2.07

**Location:** Exterior

**Finding:** Power point (external) - suspected non compliance

All external power points must be sealed to the top and sides of the connection to the brickwork or other substrate as per AS 3000 clause 1.7.1 to prevent moisture.

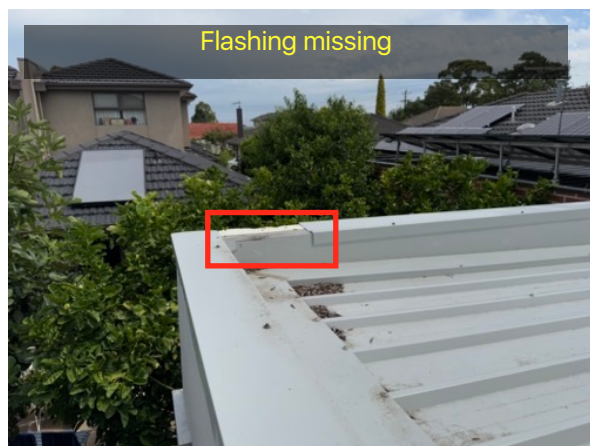
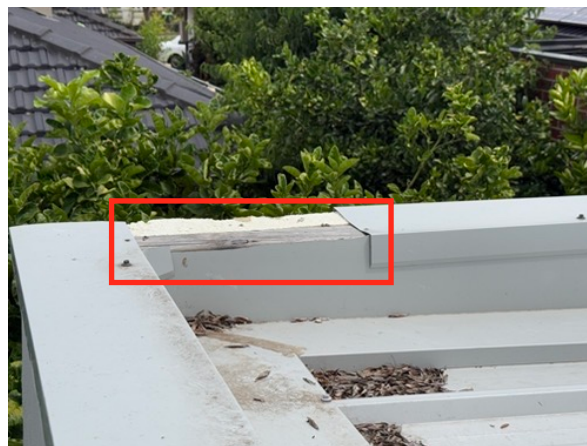
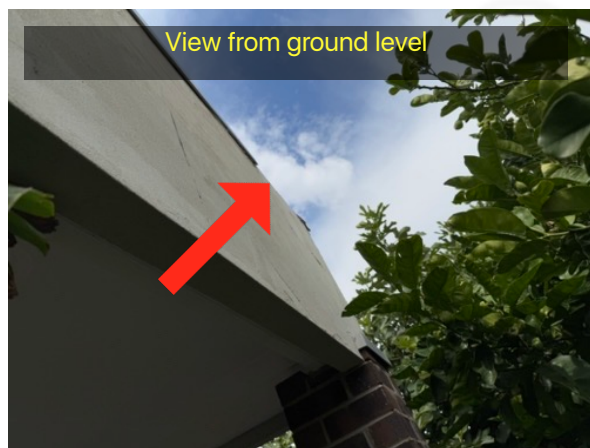
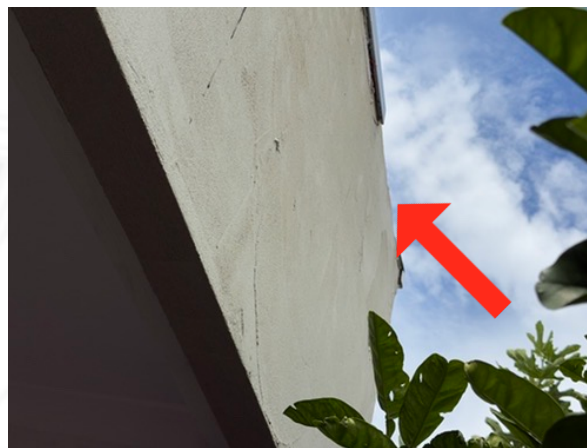
## Non Compliant 2.08

**Location:** Carport Roof

**Finding:** Parapet Flashing Missing

On inspection of the carport roof, it was noted that a section of parapet capping flashing at the rear end of the carport was missing. This must be installed immediately in order to prevent water damage to the carport ceiling and structural framework.

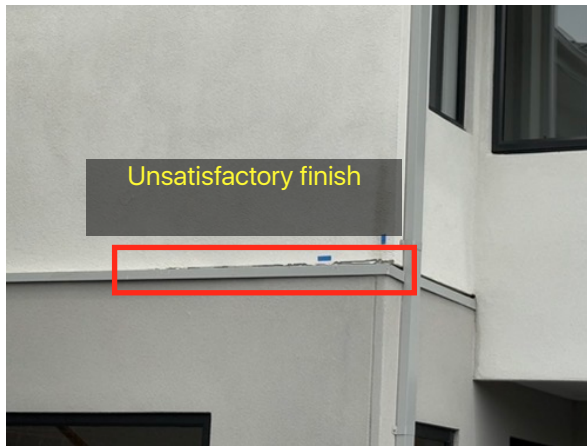
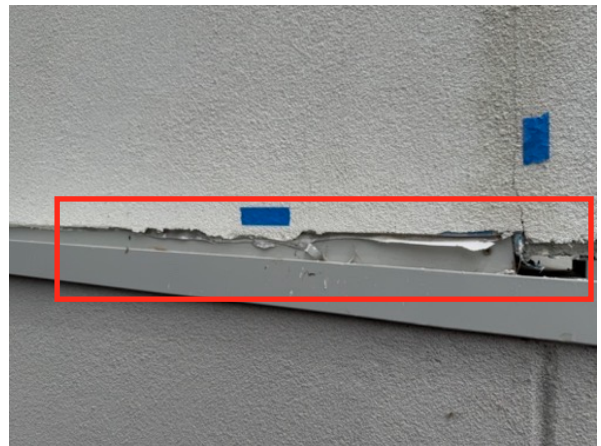
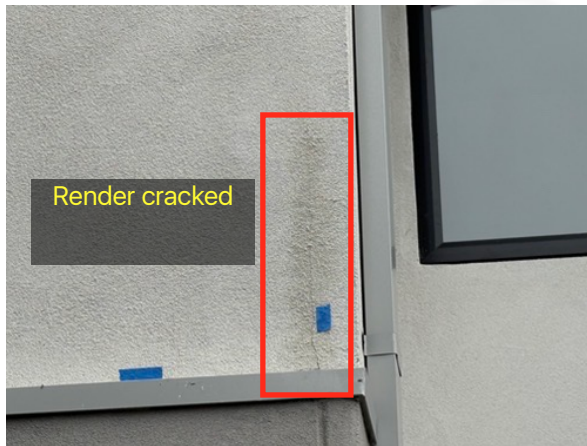
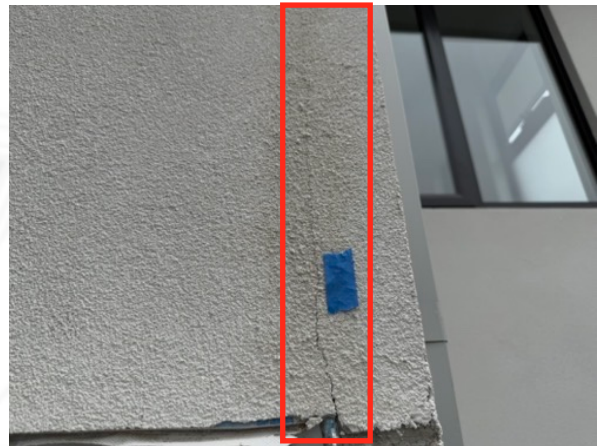
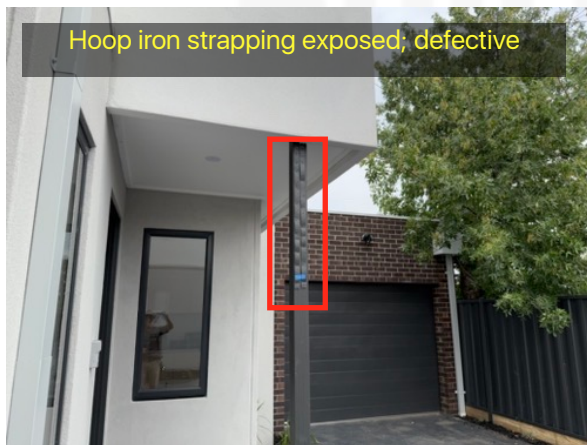
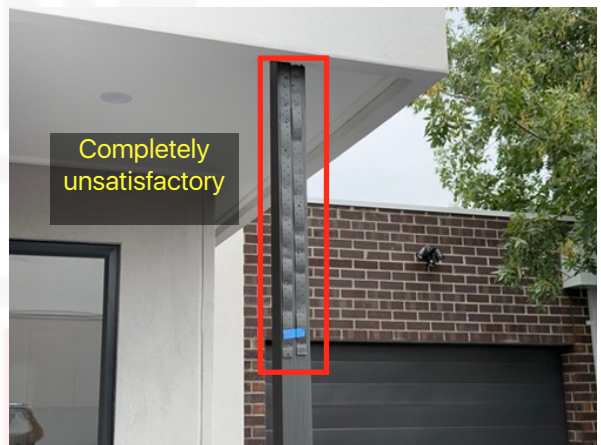
## Non Compliant 2.09

**Location:** All areas

**Finding:** Incomplete/Substandard Construction

There are a number of Building elements that were identified as being incomplete or substandard works. Substandard and incomplete work are determined by identifying a failure to achieve the minimum requirement set out in the mandated Australian Standard as outlined in the Building Code of Australia and referenced by the Manufacturers Guideline. Reference and clarification can also be made to the Guide to Standards and Tolerances for simplification.

Where a building element is installed in such as way that it fails to achieve the required minimum standard or level of finish at the time of the inspection, the builder needs to rectify the defect as soon as possible and and complete works to the required standard.

All known defects need to be rectified prior to final handover to the client.
