THE  
**BUILDING  
INSPECTION  
DOCTOR**

# Building Inspection Report

Inspection Date: 12 Mar 2026

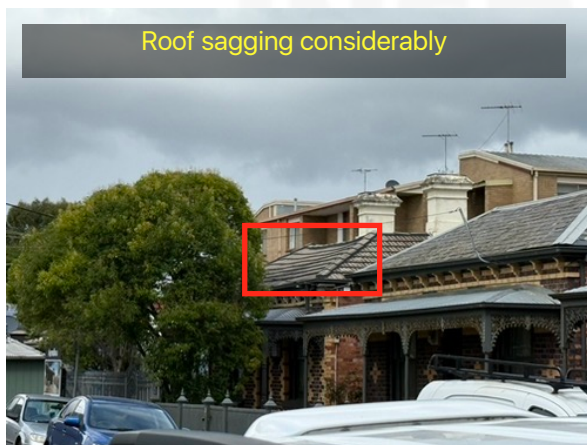
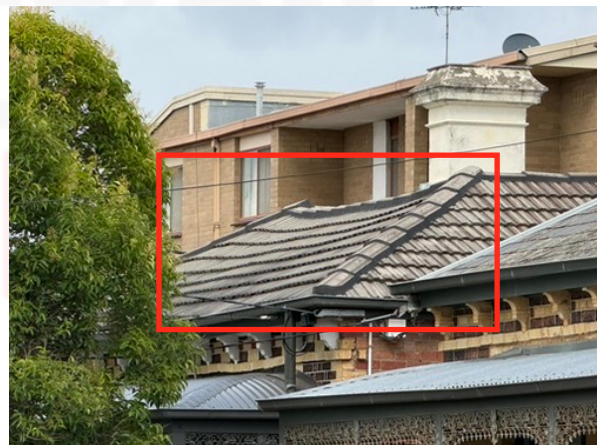
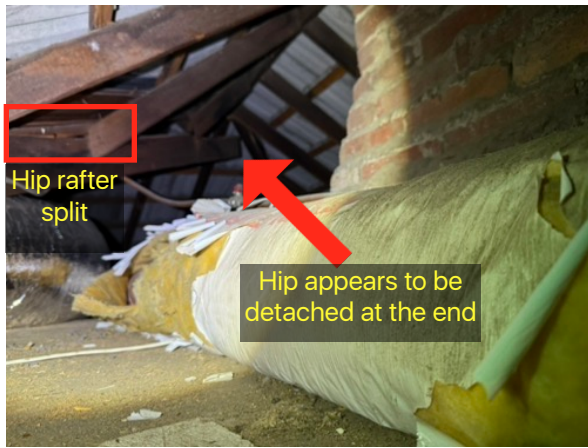
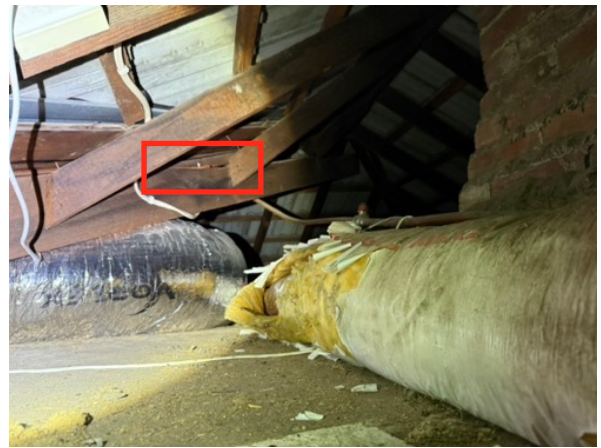
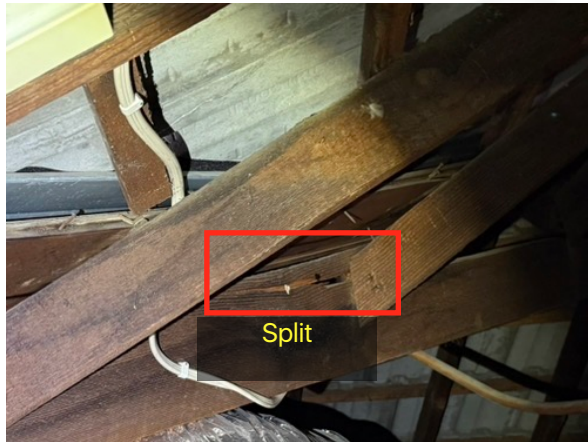
### Safety Hazard 1.01

**Location:** Roof exterior

**Finding:** Roof Frame - Sagging

On observation of the exterior of the roof, some areas were detected to be sagging considerably. Access into the roof void could not be obtained at the time of the inspection due to the manhole being too small, so photography was only possible by holding the camera and taking blind photos. On observation of the photos, a hip rafter was noted to be broken and appears to have completely detached at one end. This is not only a major structural defect, but also a potential safety hazard for anybody within the property if the roof were to collapse.

Additionally, this sagging in the roof may be potentially caused by movement of the footings under the property. As access into the subfloor area was also not possible, it could not be determined whether this may be the cause.

**The property presents several serious structural concerns requiring urgent rectification, particularly the sagging roof frame, where a broken hip rafter was detected, which is considered a major structural defect and safety hazard, necessitating urgent inspection and remedial action by a structural engineer and registered building practitioner.**

Due to the extent of the damage to the roof frame observed, Immediate appointment of a structural engineer to further inspect and provide instructions on what may be required to rectify and provide the necessary support for the roof. A registered building practitioner must be appointed to perform these works.

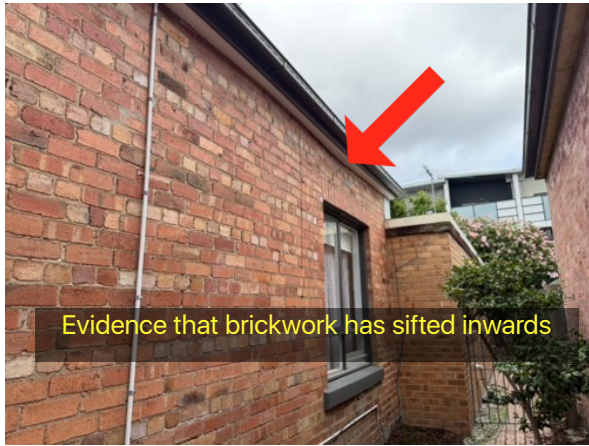
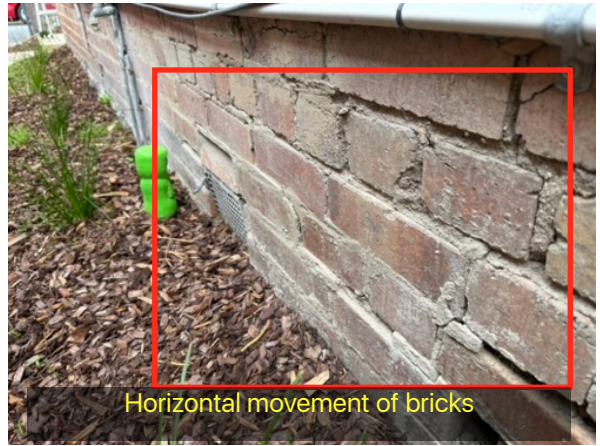
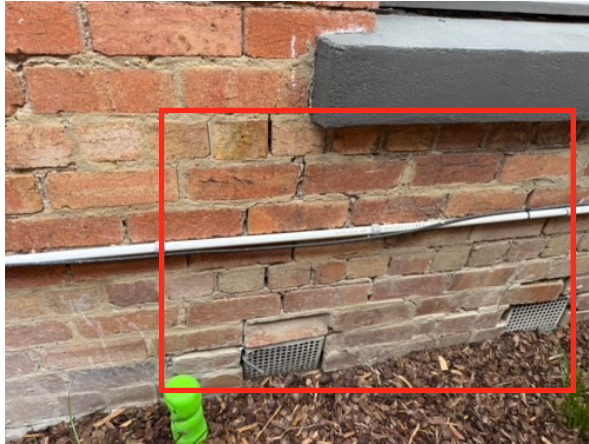
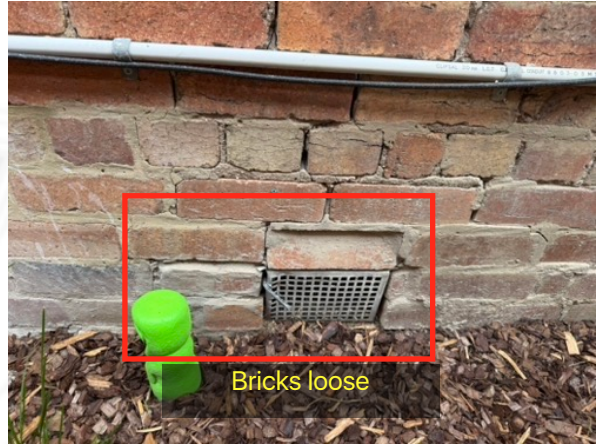
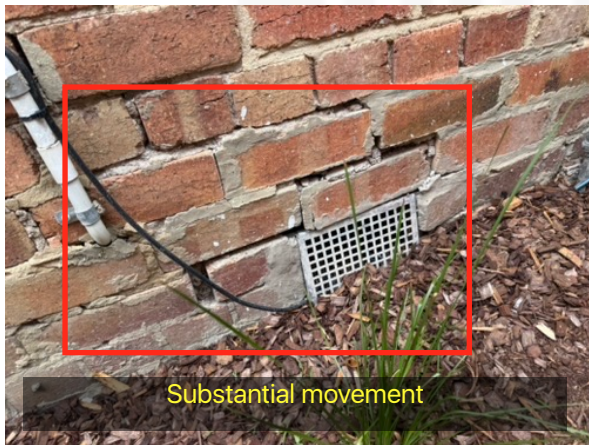
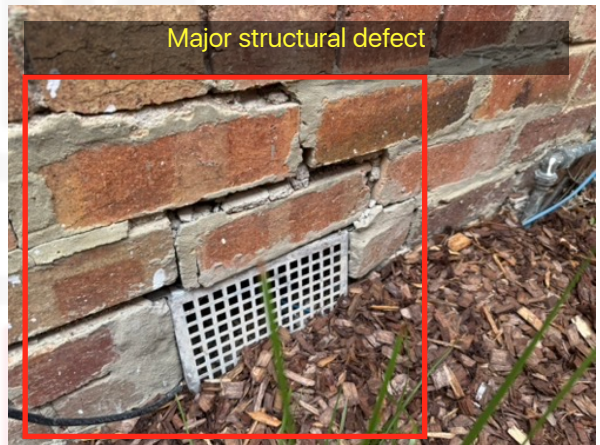
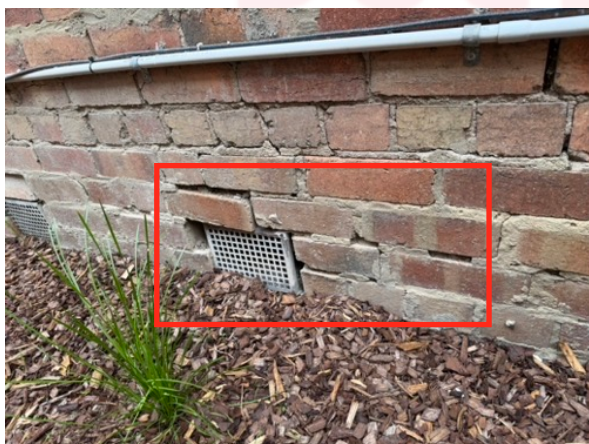
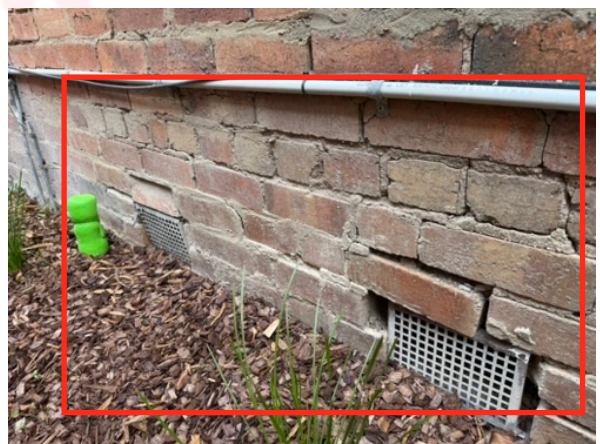
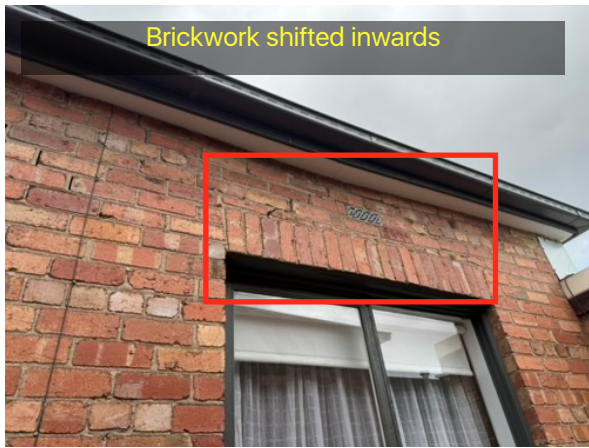
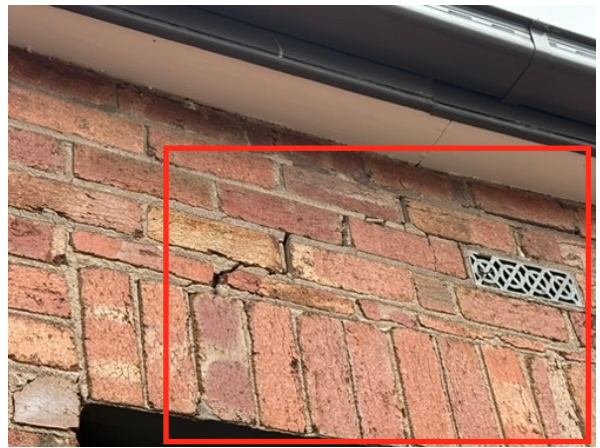
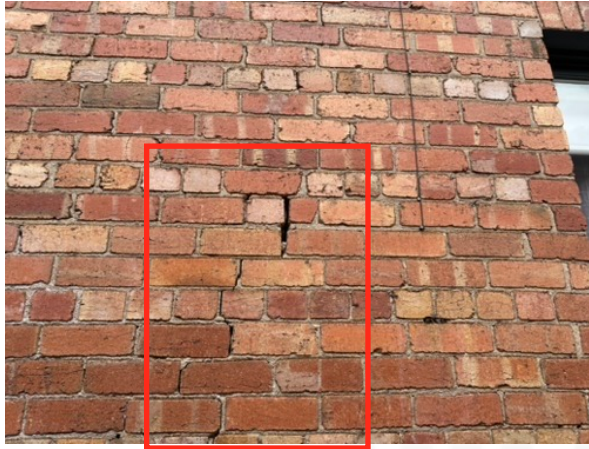
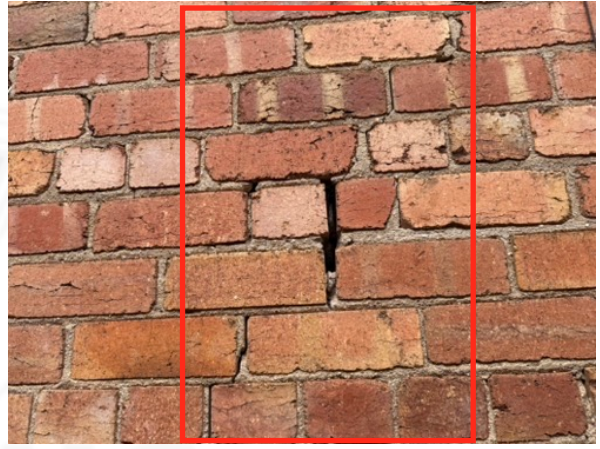
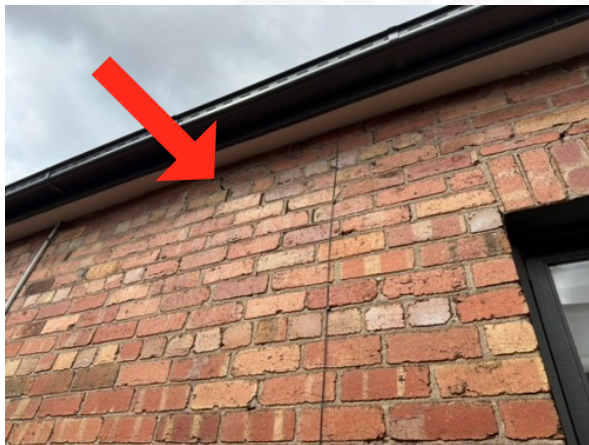
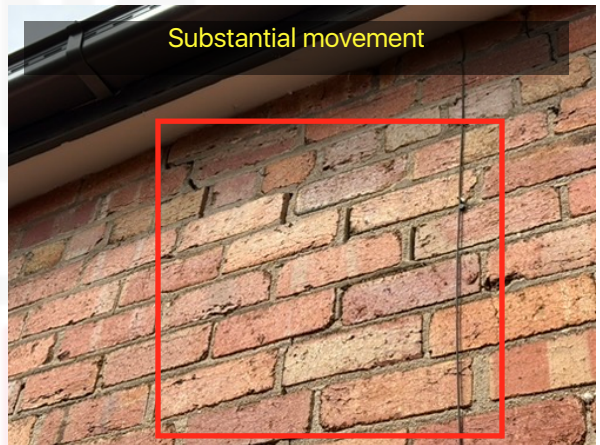
### Major Defect 2.01

Exterior Right Side

Brickwork - Substantial Movement

It was noted on the right side of the property, that the brickwork has shifted substantially, causing the brick course to separate. Several bricks were noted to be loose and sections of the brick face have shifted outwards. This movement has likely occurred from subsidence of the footings below this location. Tree roots from a tree located nearby may also be causing movement below the footings.

With the brickwork in this current condition, this is a major structural defect and a likely safety hazard. It is advised in the strongest possible terms that persons stay clear of this wall, as the brickwork could potentially collapse, causing serious injury or possibly death to persons nearby.

**Notably, substantial movement in the brickwork on the right side of the property is a major defect and a potential safety hazard, likely due to subsidence of the footings, requiring the immediate involvement of a structural engineer.**

Urgent appointment of a structural engineer is required to immediately inspect the home and provide instructions on what is required for possible rectification of the damaged wall.

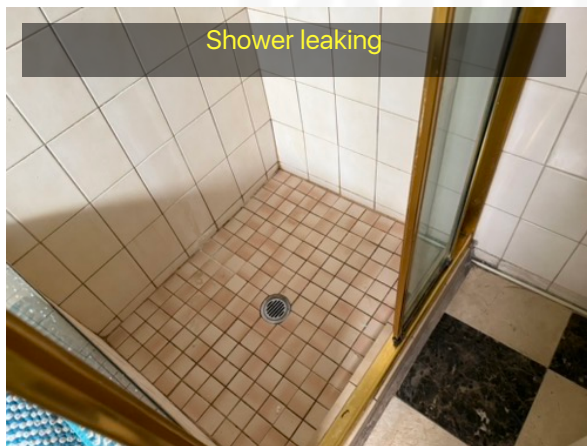
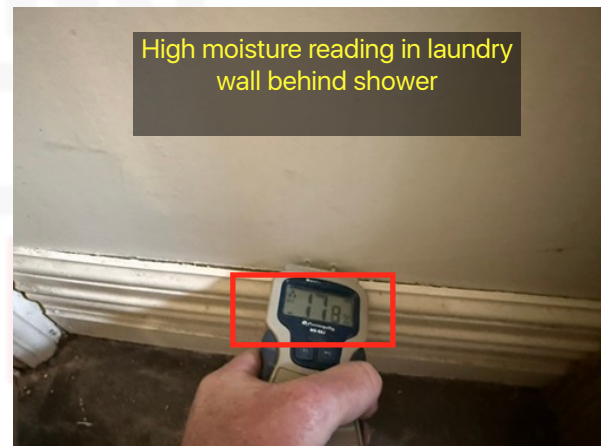
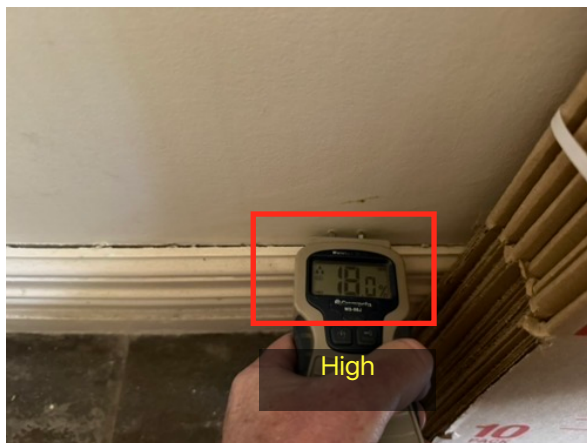
## Major Defect 2.02

**Location:** Bathroom

**Finding:** Shower - Damp

Damp is evident to the lower 300mm of adjoining walls to the shower alcove. This defect is quite common, and is suspected to have been caused by moisture permeating through the shower wall. Leaking pipes within the adjoining wall is also a possible cause.

Damp (or structural damp) refers to the presence of unwanted moisture in the structure of a building, either as the result of intrusion from outside, or condensation from within the structure. In the shower area, internal water leaks or other sources of excessive moisture are generally the cause of damp. Moisture meter readings taken from the wall in the laundry located directly behind the shower measured high at the time of inspection. This is considered a major structural defect due to the moisture potentially affecting the framework of the wall.

Unmanaged damp in the shower recess is likely to facilitate the formation and development of mould and fungi growth, decaying associated building materials and compromising their structural integrity. It is important to address damp conditions, as the World Health Organisation notes that excess moisture leads - on almost all indoor materials - to growth of microbes such as moulds, fungi and bacteria, which subsequently emit spores and other matter into the indoor air. Exposure to these contaminants is associated with a wide range of respiratory and other health-related problems.

Full renovation of the bathroom is likely to be required to prevent further damp conditions. Immediate appointment of a registered building practitioner is strongly advised to provide a quotation for urgent replacement/renovation of the bathroom.

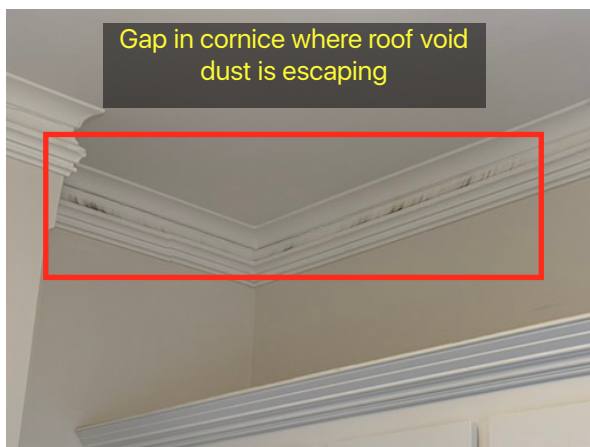
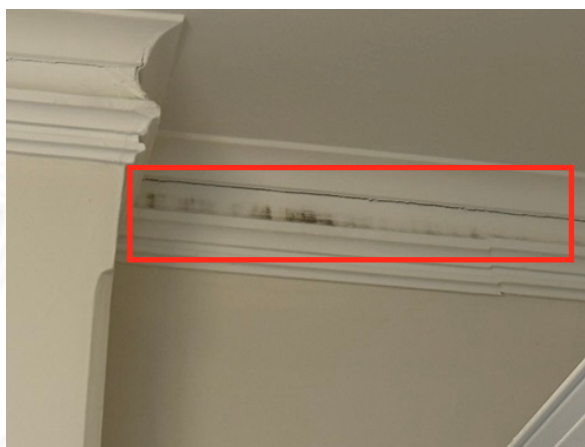
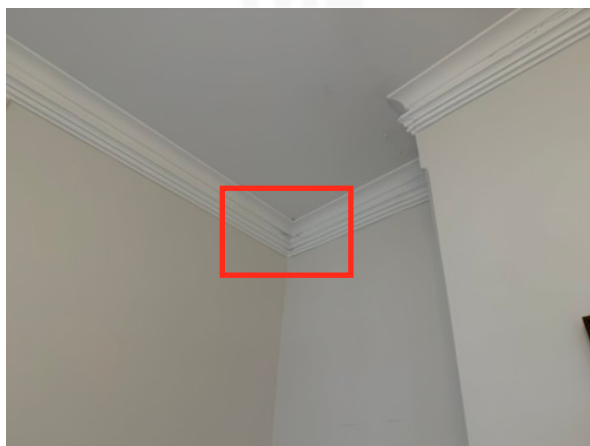
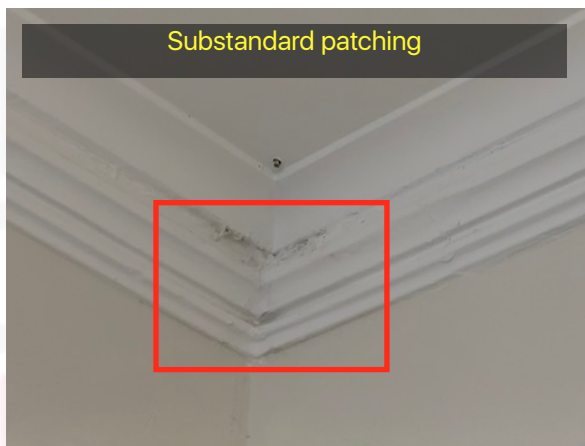
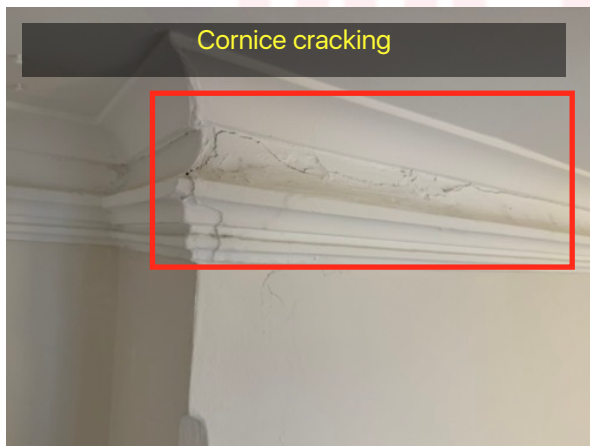
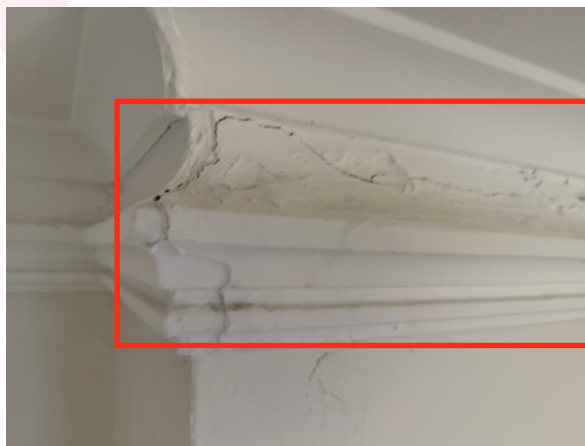
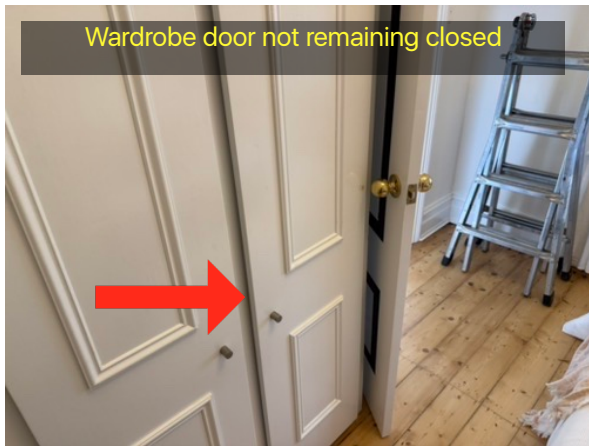
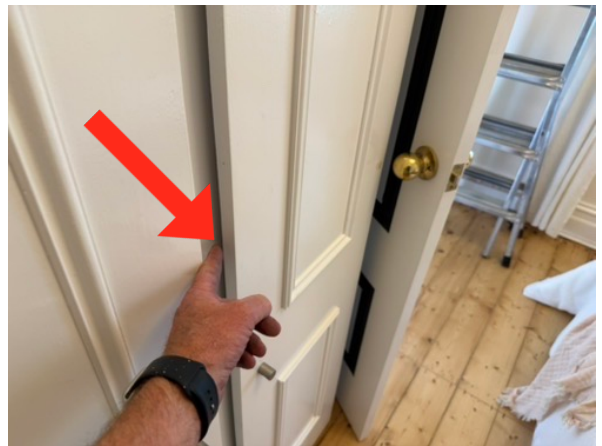
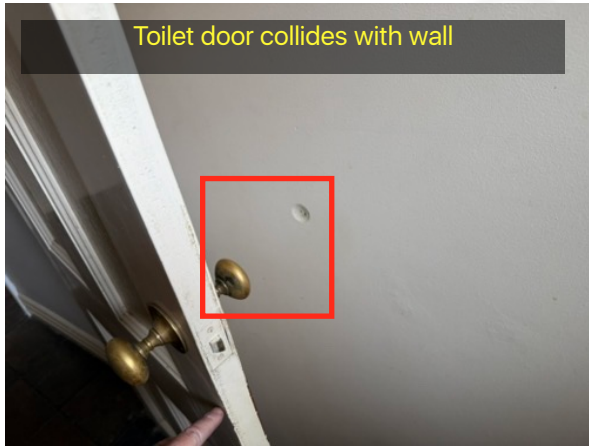
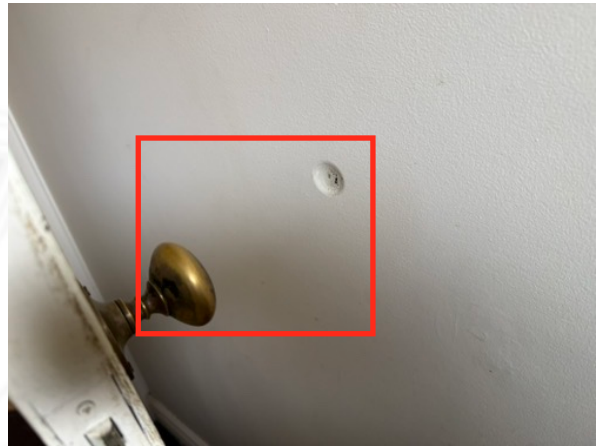
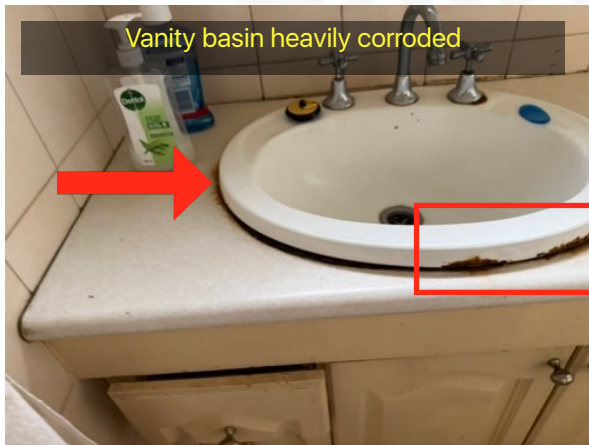
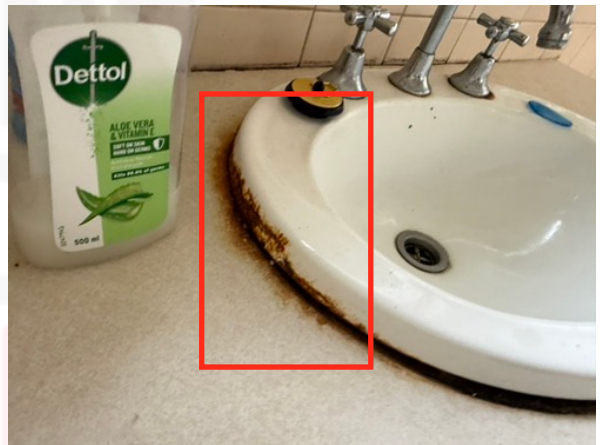
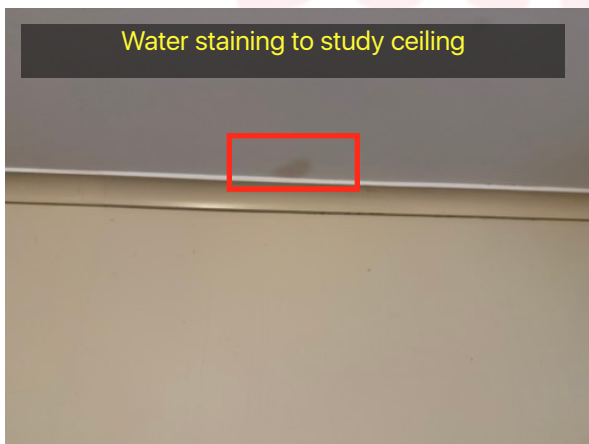
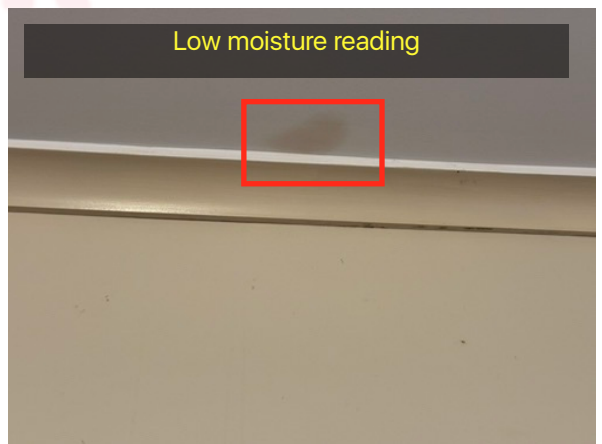
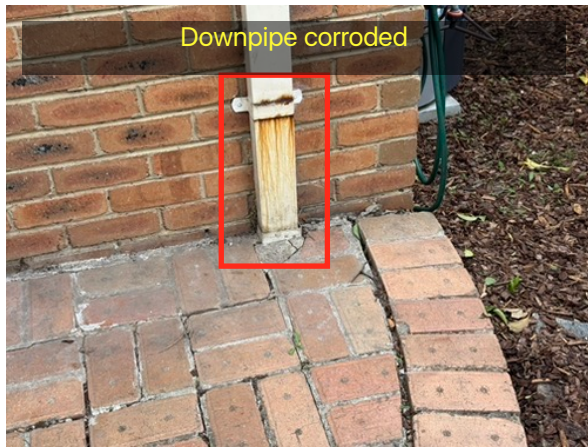
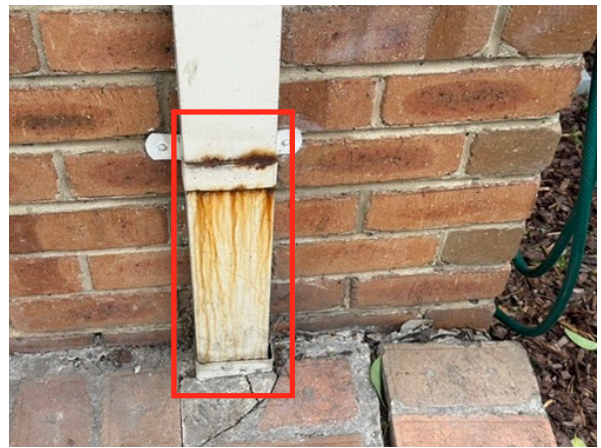
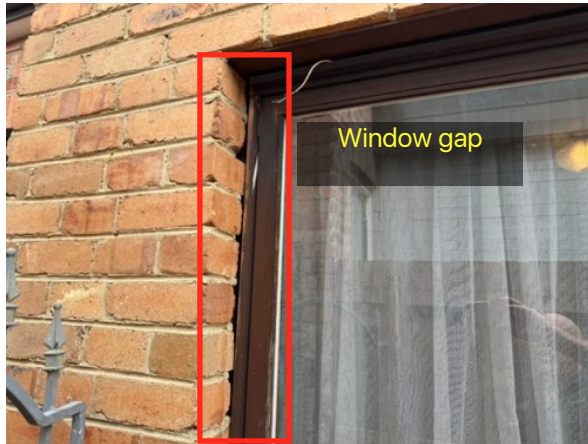
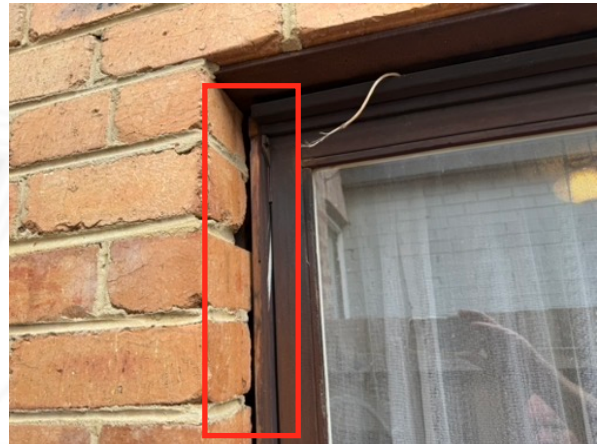
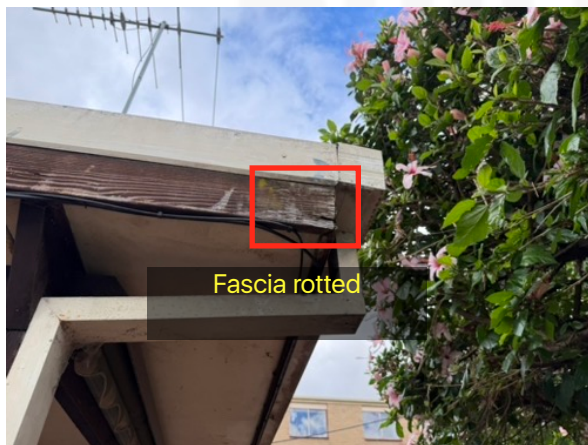
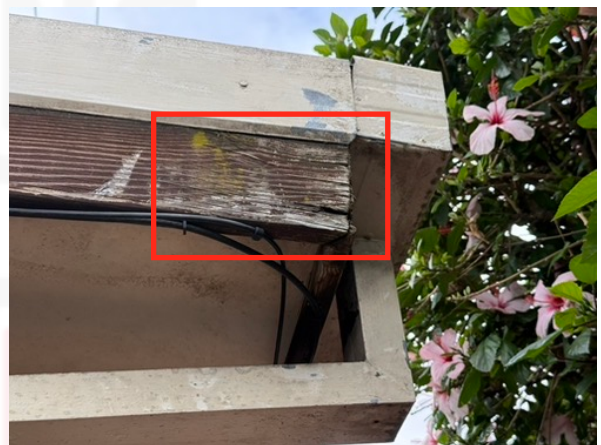
## Minor Defect 3.01

**Location:** All areas

**Finding:** Miscellaneous Defects

Additional photos of miscellaneous minor defects are provided for your general reference.
