THE
**BUILDING
INSPECTION
DOCTOR**

Dilapidation Inspection Report

Inspection Date: 23 Nov 2021

Building Type: Townhouse

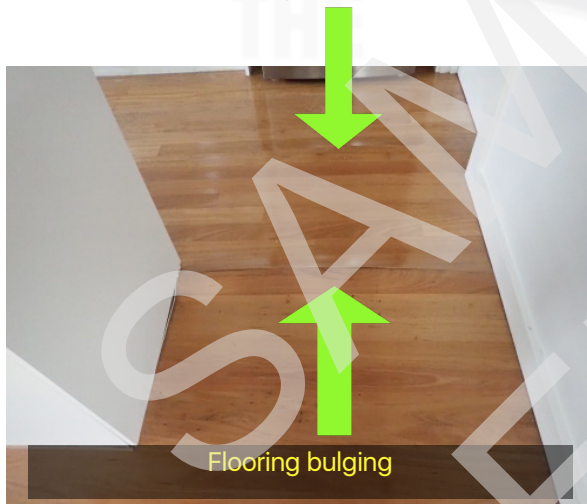
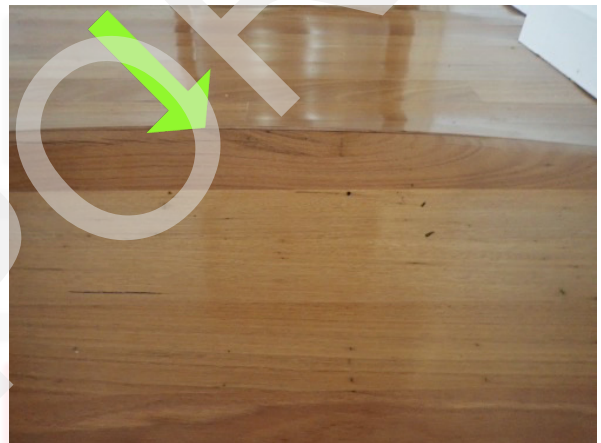
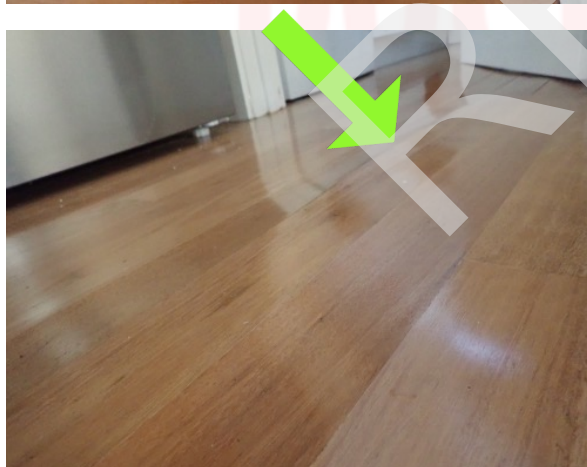
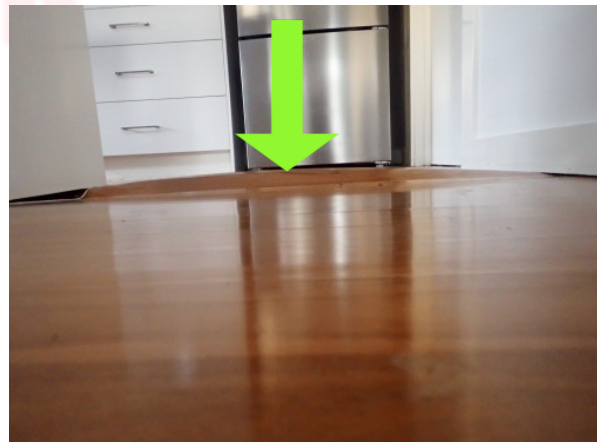
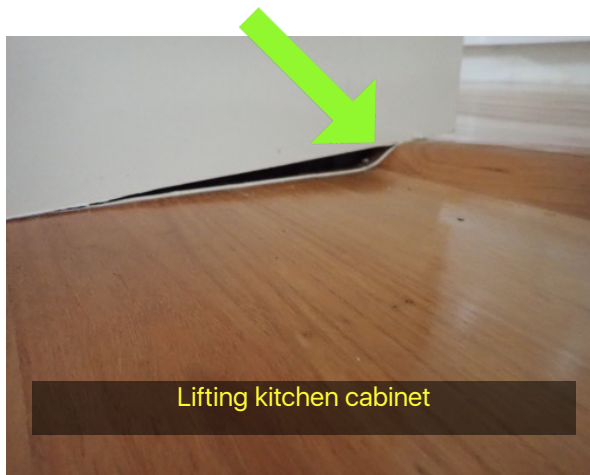
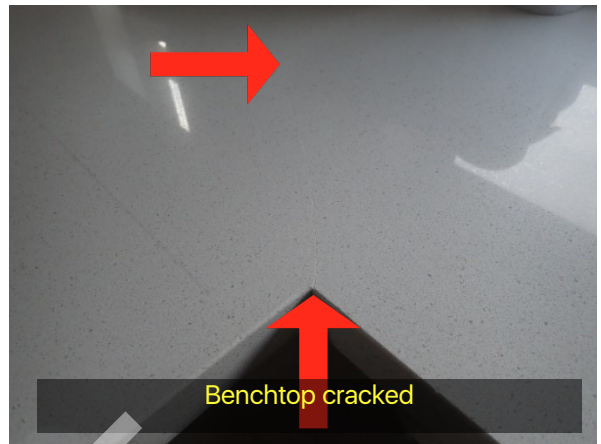
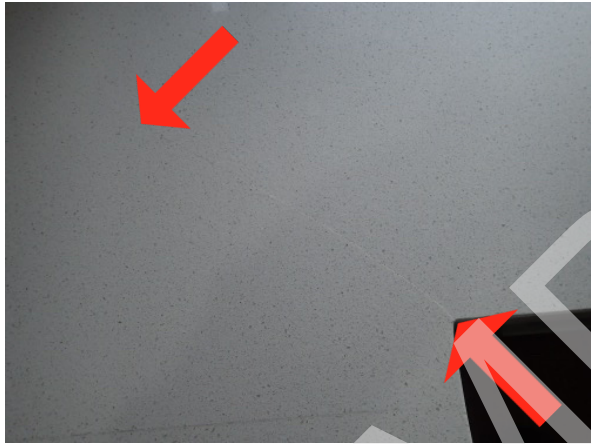
Major Defect 2.01

Location: Kitchen

Finding: Kitchen Flooring - Lifted

The kitchen flooring was observed to have lifted/bulging in two locations, likely caused by swelling from moisture ingress between the flooring and concrete slab. In one section the floor has lifted under the kitchen cabinetry, causing the stone benchtop to crack at the other end. See photos attached for further information.

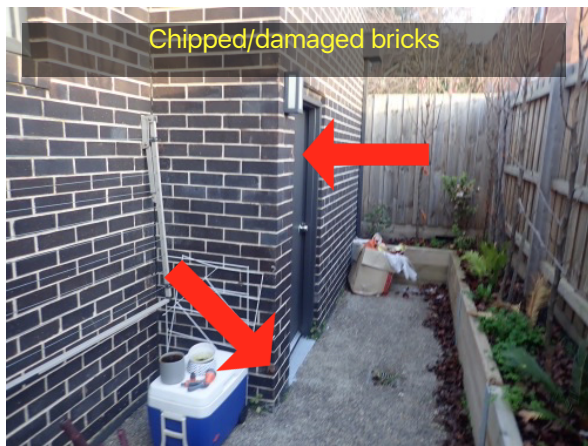
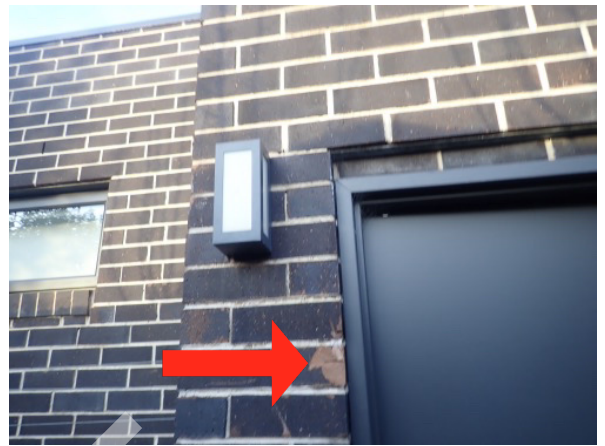
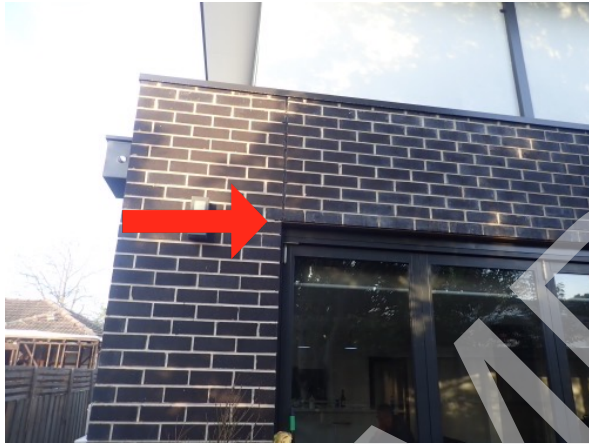
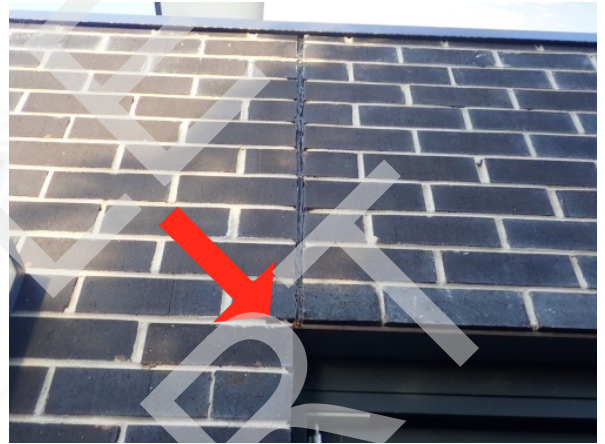
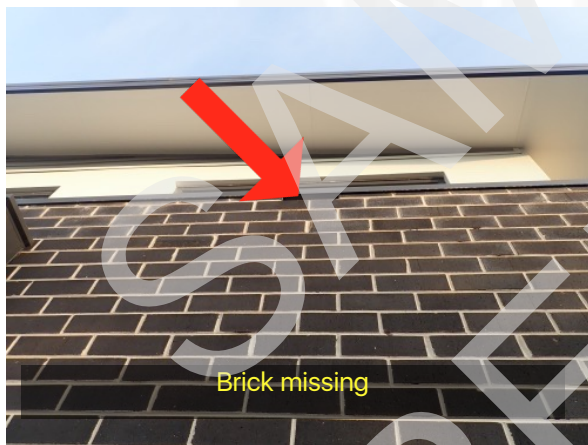
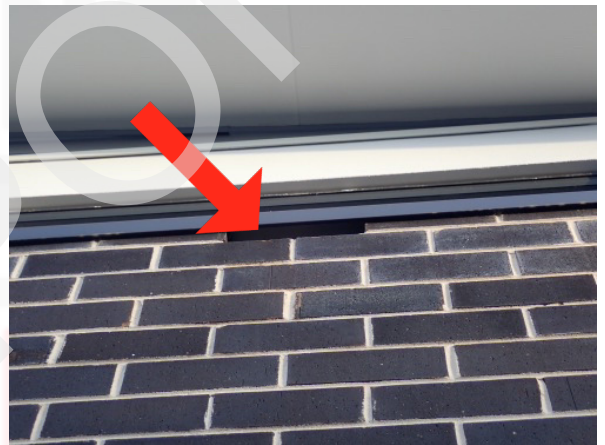
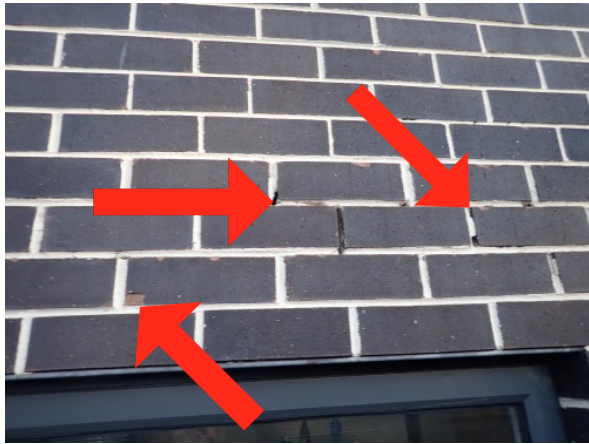
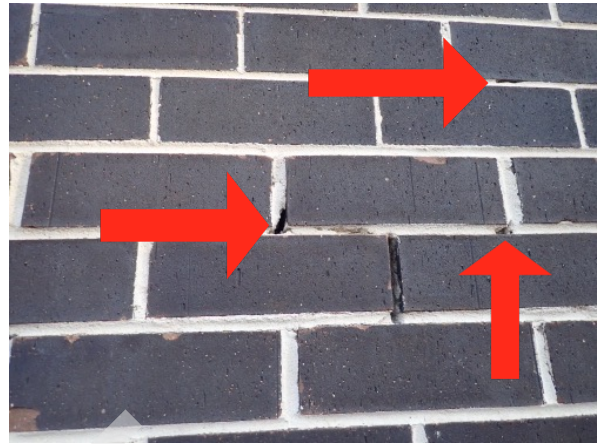
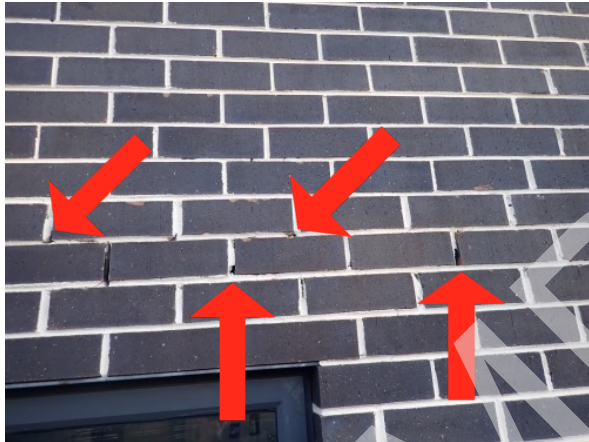
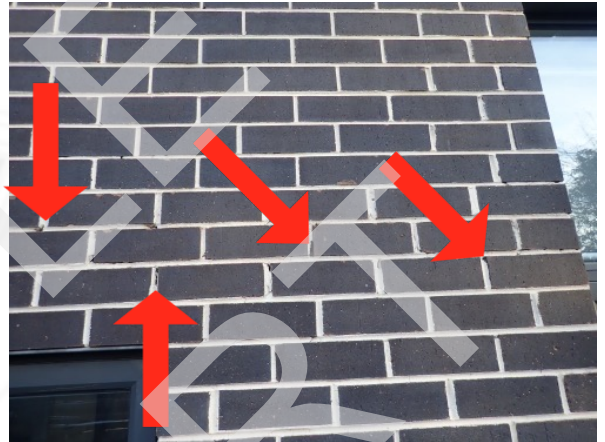
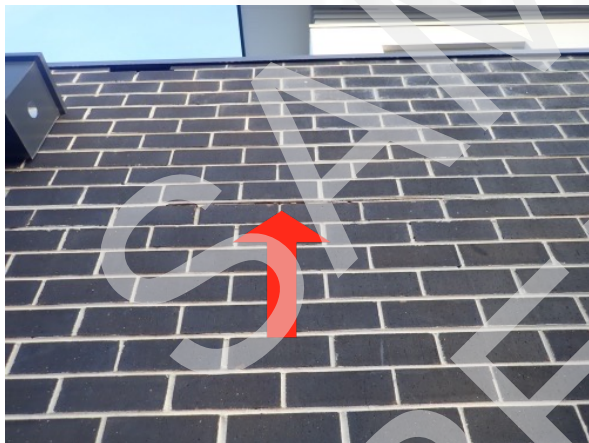
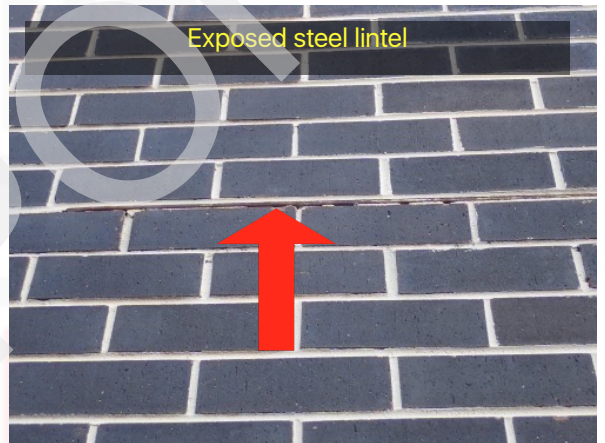
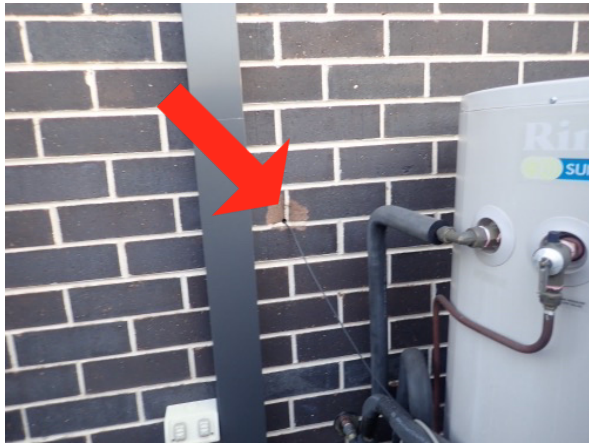
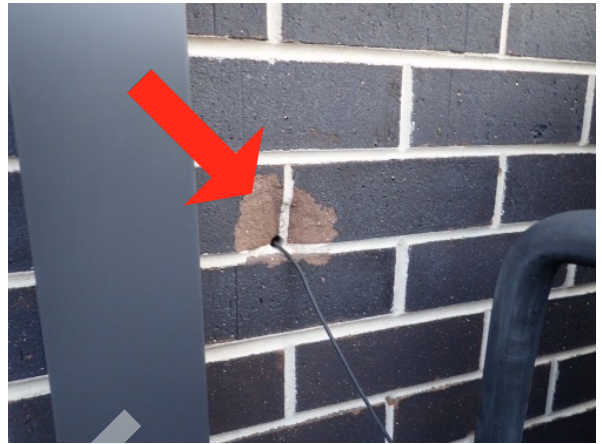
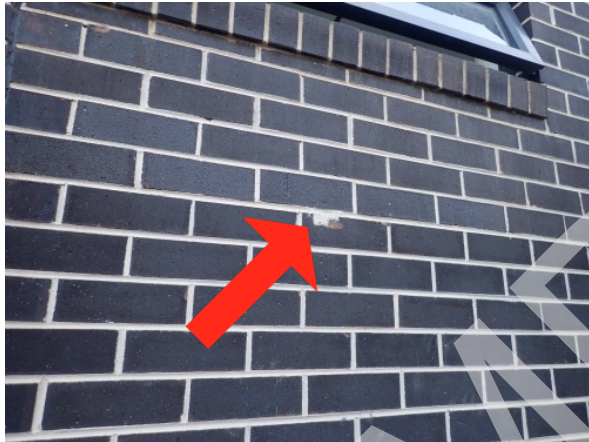
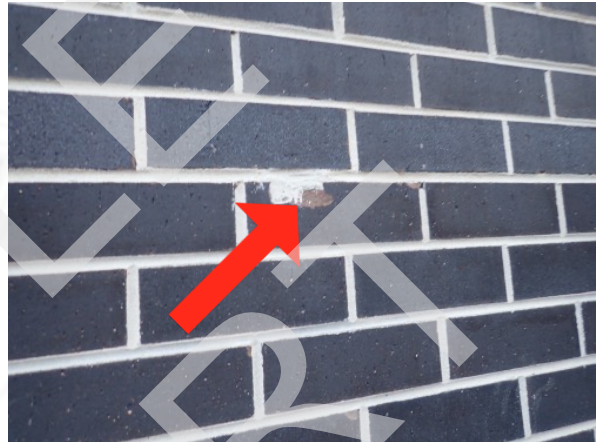
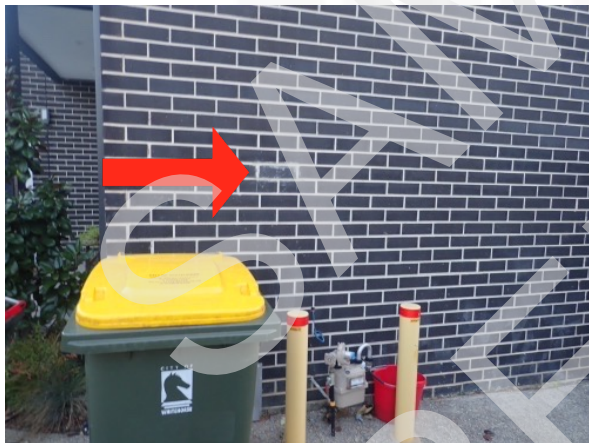
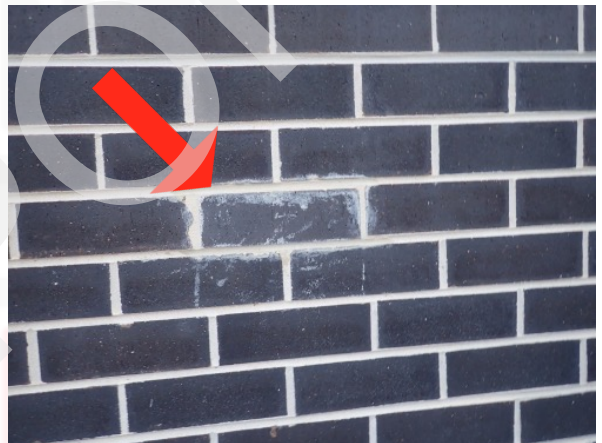
Minor Defect 3.01

Location: All External Areas

Finding: Brickwork - Voids & Holes

Voids and holes in the brick mortar were detected in several locations around the property, particularly on the north facing brick wall. Additionally, a brick was noted to be completely missing.

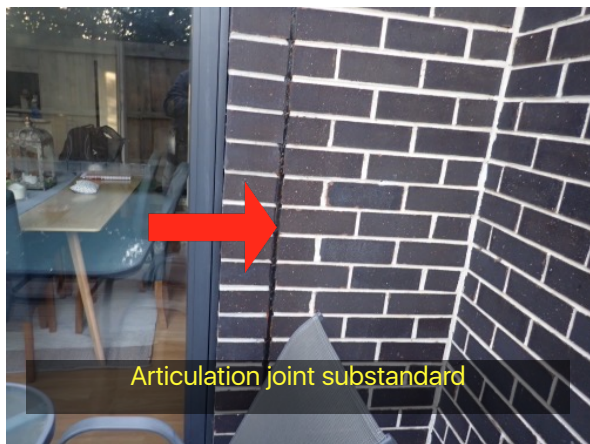
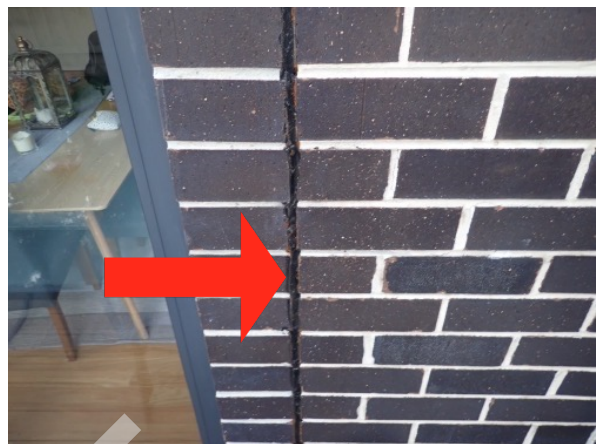
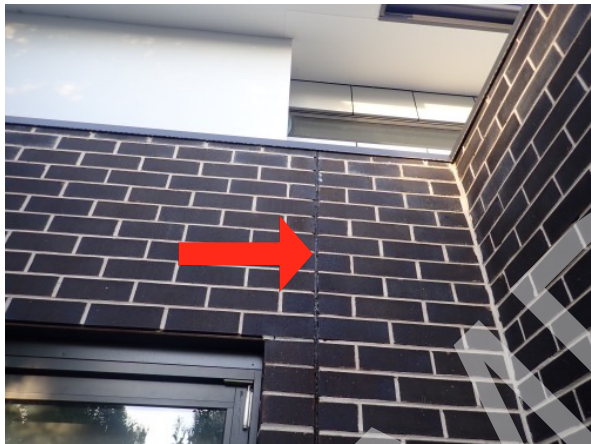
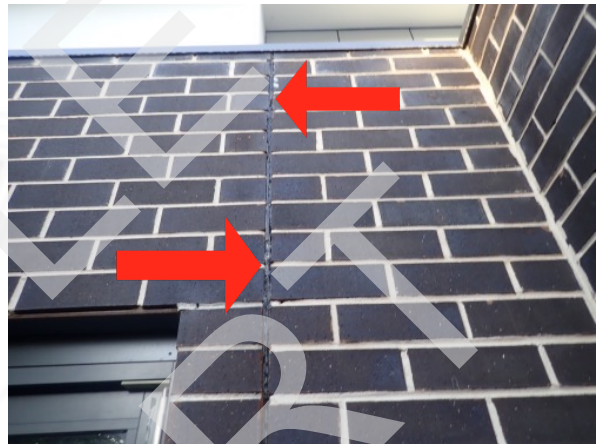
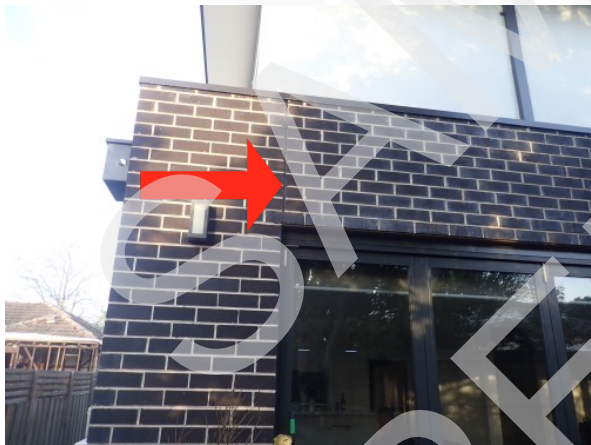
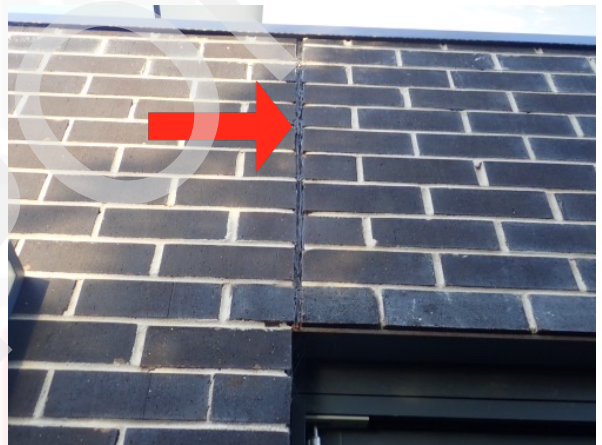
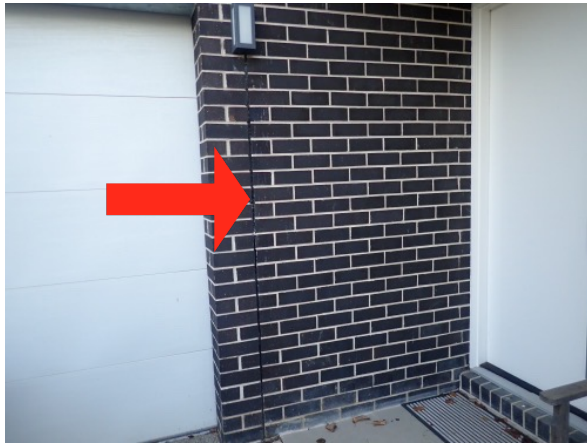
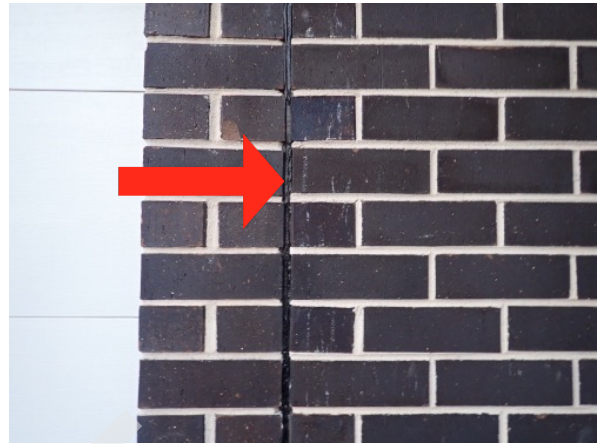
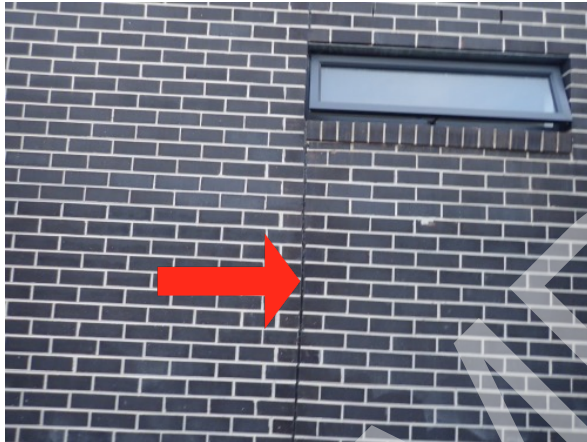
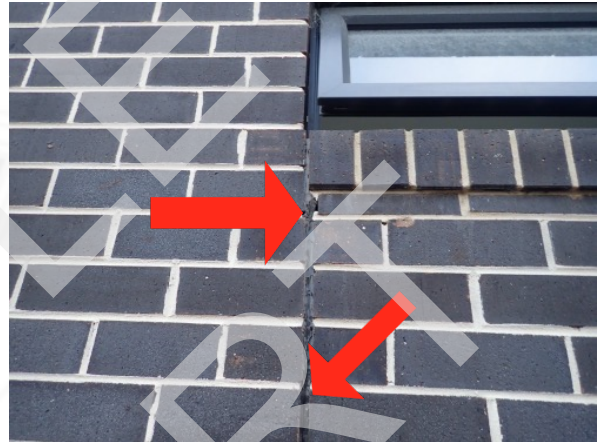
Minor Defect 3.02

Location: All External Areas
Finding: Articulation joints - Substandard

The articulation or control joints throughout the exterior brickwork appear to have been installed/applied to a substandard level.

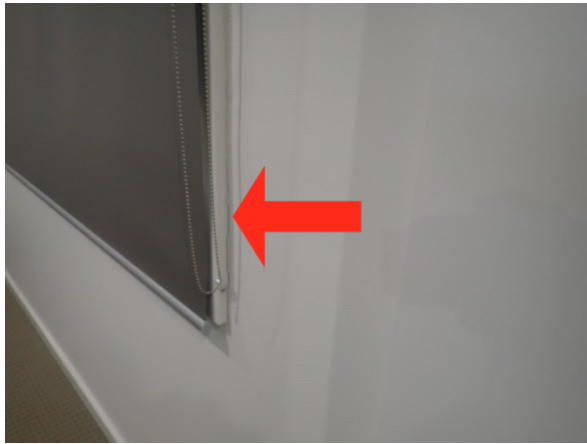
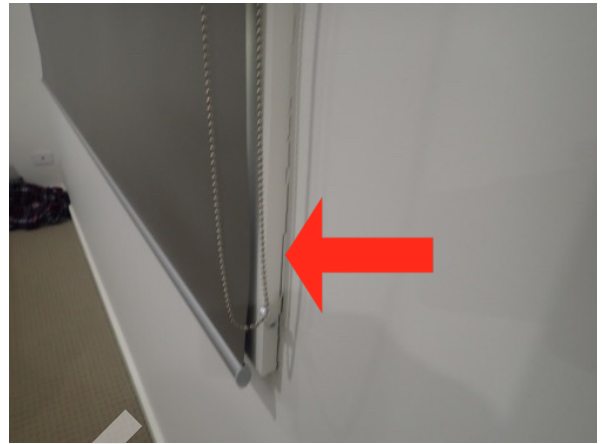
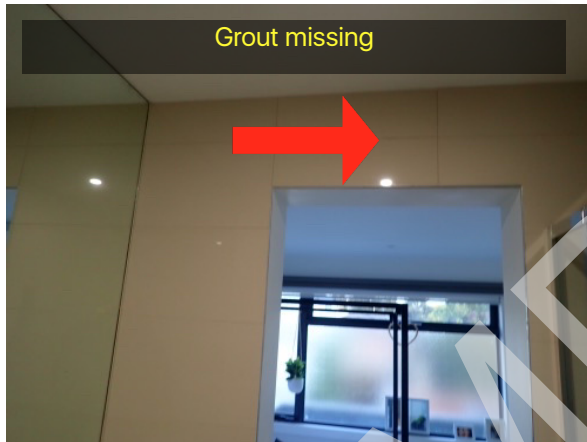
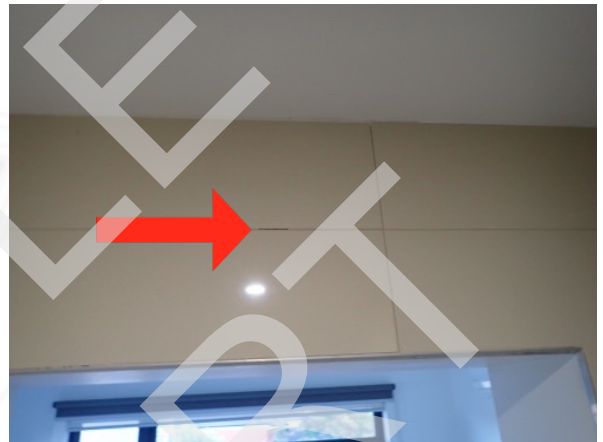
For your information 4.01

Location: Ensuite
Finding: Cracking [Dilapidation]

Cracking to the joints of differing building material junctions was identified in several locations around the property at the time of inspection. This cracking should be monitored frequently to identify whether further cracking results.

At the time of inspection, the cracking in these areas is noted in the images attached.
