# Handover Stage Inspection Report

Inspection Date: 5 Jun 2025

Building Type: Townhouse

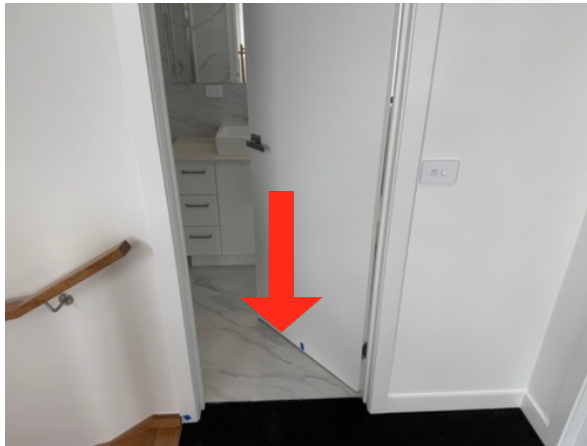
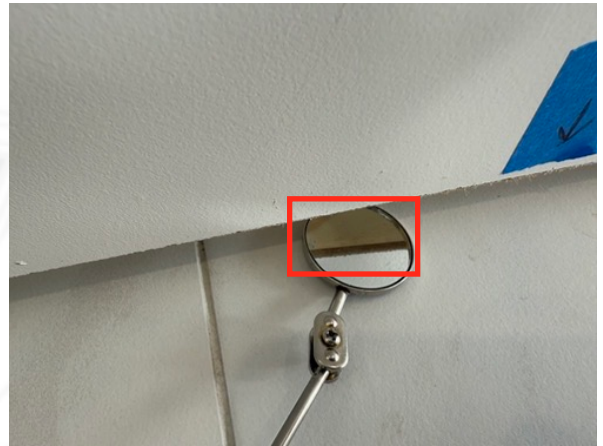
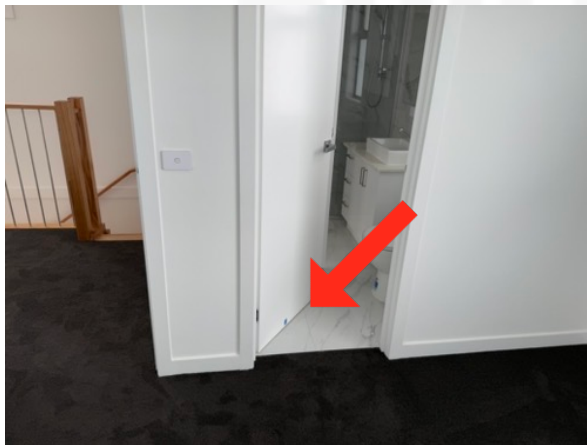
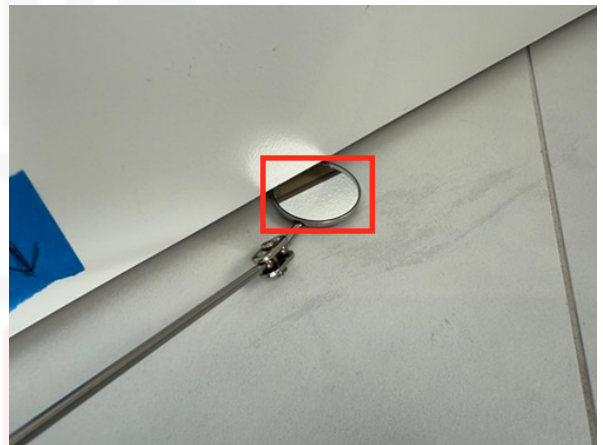
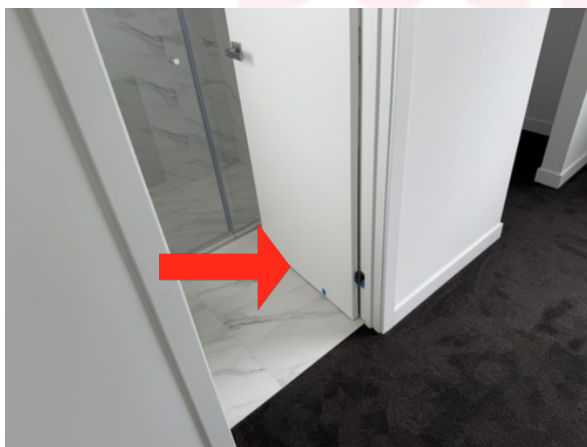
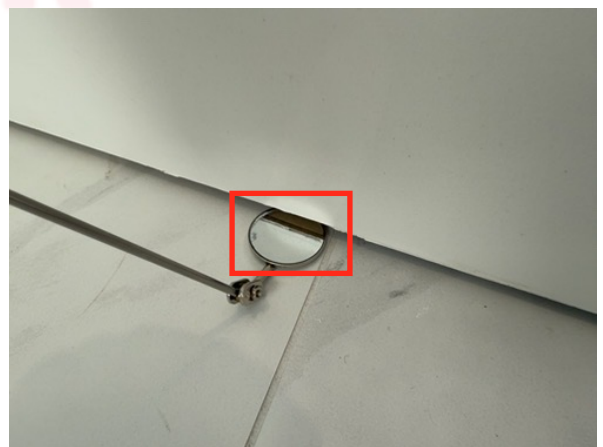
**Finding:** Door edge sealing - defective

It was observed that the top and bottom edges of the external and wet area doors have not been painted.

All edges of external and wet area doors must be sealed to prevent moisture ingress and to comply with Standards and Tolerances and the door manufacturers specifications.

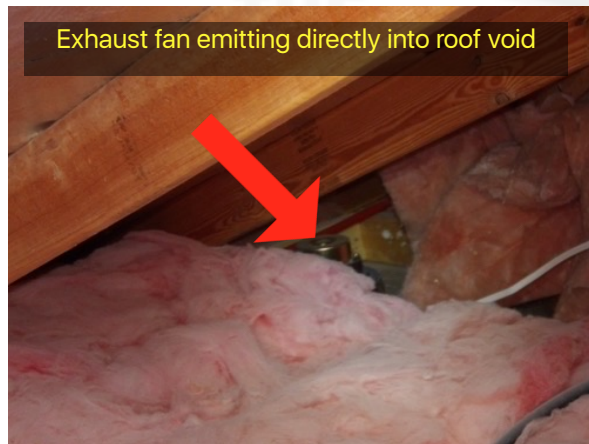
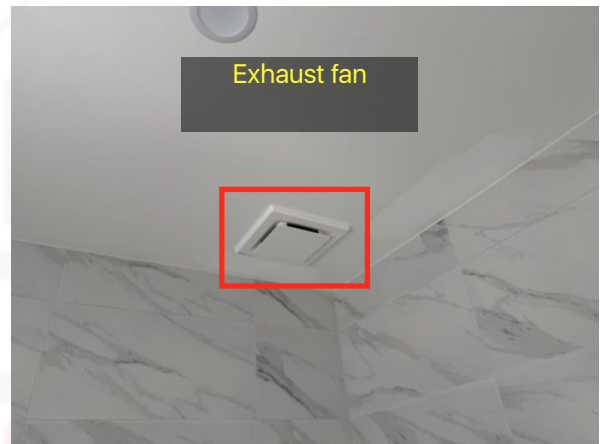
The exhaust fans were found to lead directly into the roof space, rather than venting to the exterior of the building. No evidence of external vents could be found for the lower storey exhaust fans, so it is strongly suspected that these may be emitting directly into the floor space between the two levels.

As the roof is lined with sarking, the exhaust fans must be vented externally by way of ducts or flues.

These require rectification by the builder prior to final handover to the client.

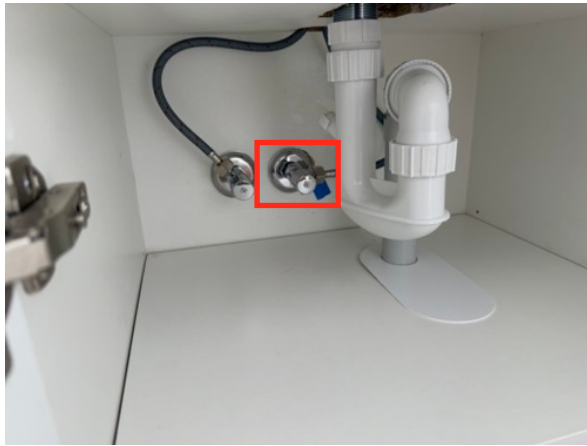
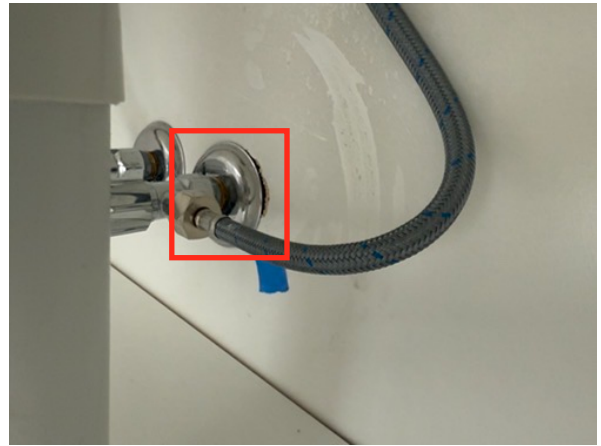
**Location:** Wet Areas

Plumbing holes are defective if they are not:

b) fitted through neat minimal size penetrations (in the case of cabinetwork)

c) fitted with tight fitting cover plates or collars with penetrations kept to the smallest size practicable.

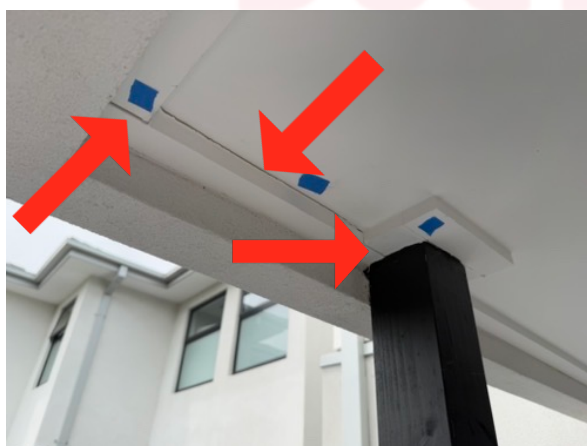
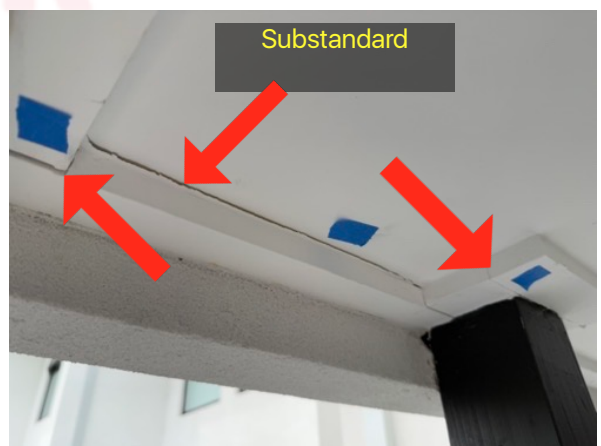
There are a number of Building elements that were identified as being incomplete or substandard works. Substandard and incomplete work are determined by identifying a failure to achieve the minimum requirement set out in the mandated Australian Standard as outlined in the Building Code of Australia and referenced by the Manufacturers Guideline. Reference and clarification can also be made to the Guide to Standards and Tolerances for simplification.

Where a building element is installed in such as way that it fails to achieve the required minimum standard or level of finish at the time of the inspection, the builder needs to rectify the defect as soon as possible and and complete works to the required standard.

All known defects need to be rectified prior to final handover to the client.
