Lockup Stage Inspection

Inspection Date: 6 Jun 2025

Company Name: The Building Inspection Doctor

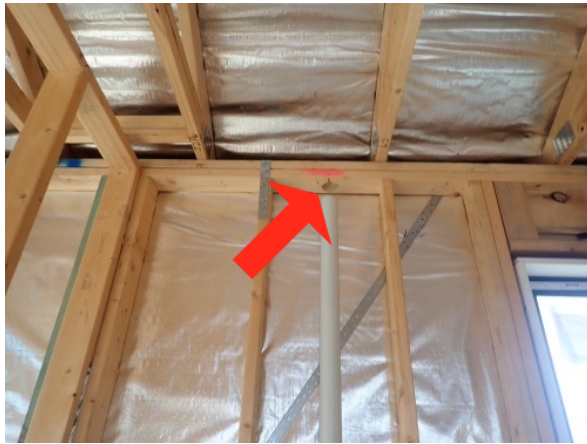
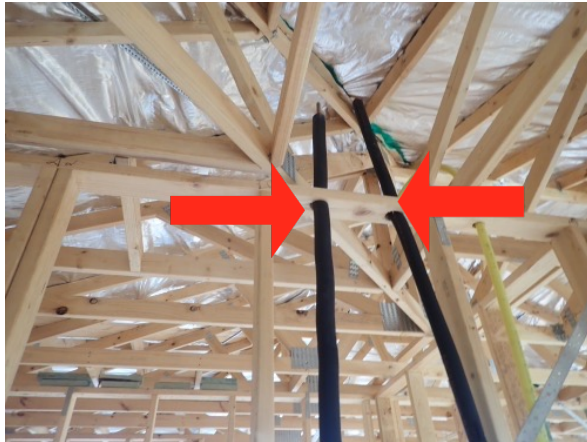
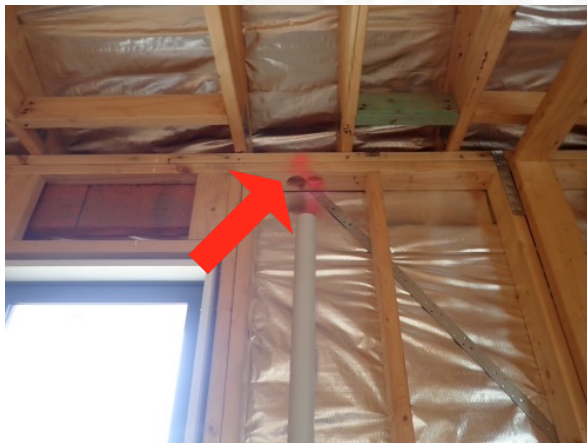
Non Compliant 2.02

It was observed during inspection that the minimum distance between holes for services (electrical and / or plumbing) and notching has not been maintained. The AS1684 requires a minimum distance between holes and notching in a 90mm stud and top plates is 270mm. The standard states that the distance between holes and other holes or holes to notches in studs can be no closer than $3 \times D$. This is calculated as $3 \times$ the depth of the material used. In this case $3 \times D$ is $3 \times 90\text{mm}$ or 270mm minimum distance apart.

These plates and studs require additional strengthening prior to the next stage commencing. Flat steel strap (hoop iron strap) affixed using flat head nails, not screws, running past each penetration by minimum 150mm to both sides of the plate/stud will suffice.

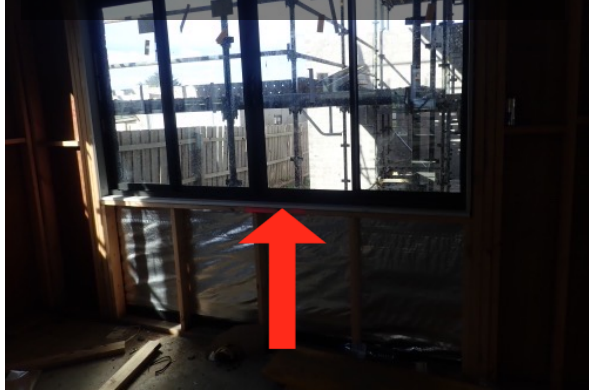
On inspection of the windows in the kitchen/family room area, it was noted that the windows in this have not been installed as per the manufacturers (A & L Windows) specifications, which specifies full width packers between the window sill and sill trimmer plate and a minimum spacing of 20mm between the top of the window frame and head trimmer.

No packers between sill and sill trimmer plate

These windows require reinstallation as per the manufacturers specifications and AS 1684.4; clause 6.2.3.

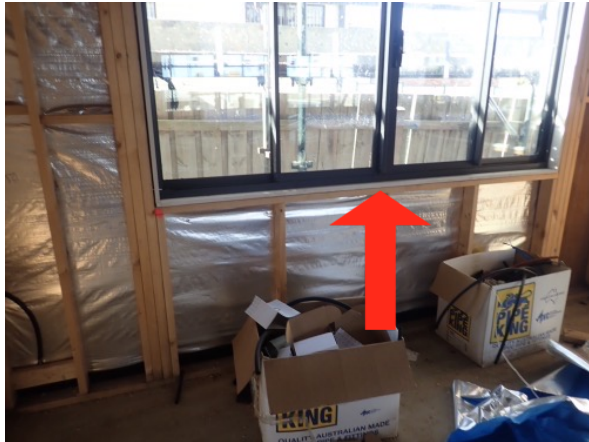
Window installed directly onto sill trimmer. Packers required under sill

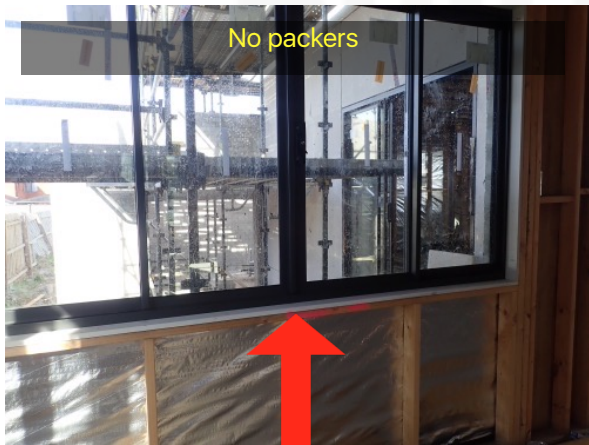
No packers

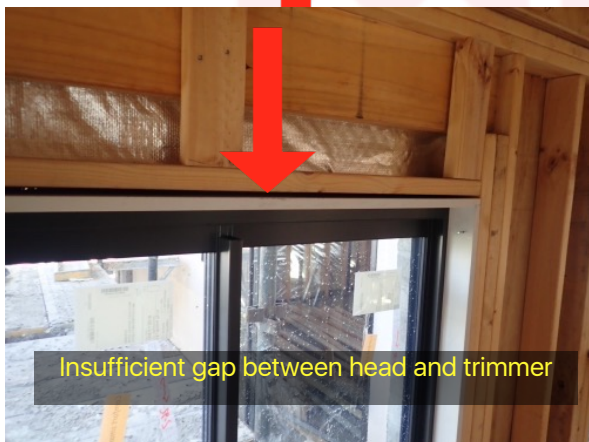
Insufficient gap between head and trimmer

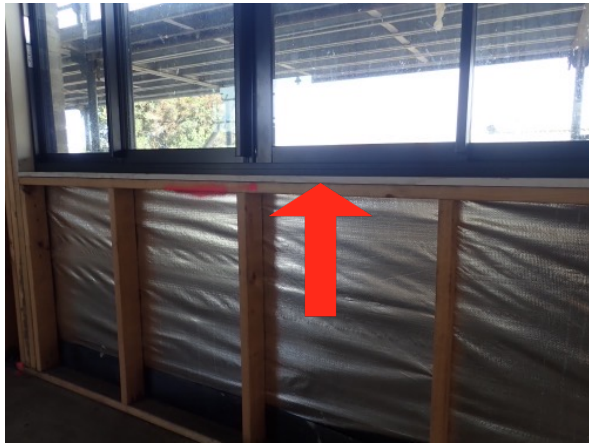
Minimum 20mm required

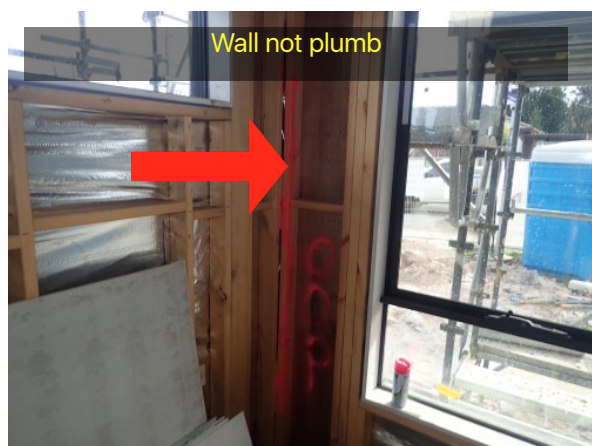
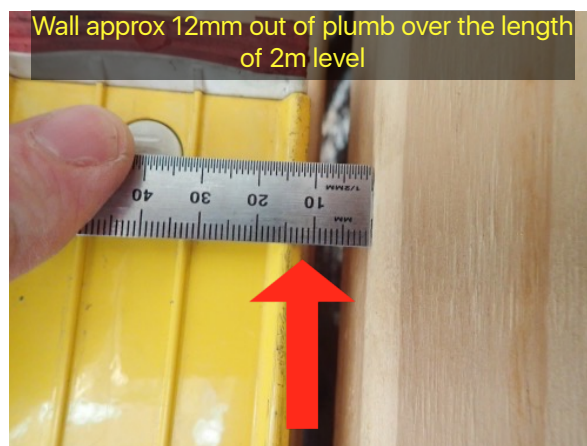
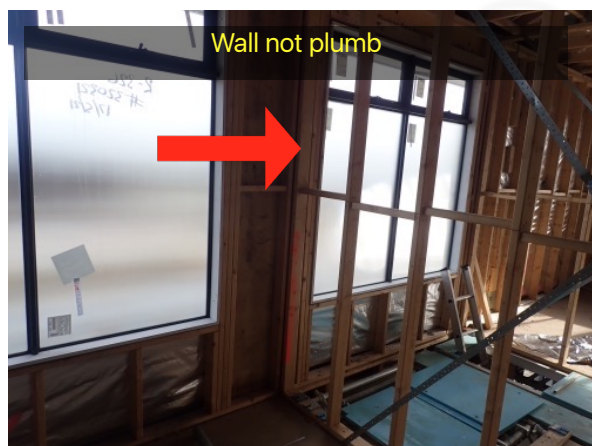
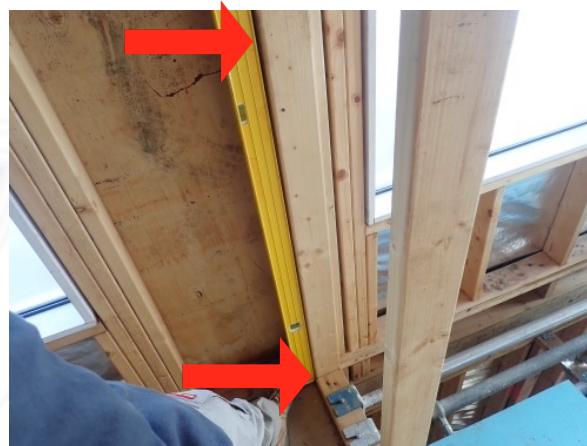
Non Compliant 2.04

Posts and wall frames are defective if they deviate from vertical by more than 5 mm over a 1.8 m height as per the Guide to Standards and Tolerances 2015.
